**Strengthening and Repair of RC Beams with Cementitious Repair
Materials**

The Islamic University of Gaza
Deanship of Higher Studies
Faculty of Engineering
Civil Engineering Department
Design and Rehabilitation of
Structures.

A Thesis Submitted in Partial Fulfillment of the Requirements for Degree of
Master of Science in Civil Engineering -Rehabilitation and Design of Structures

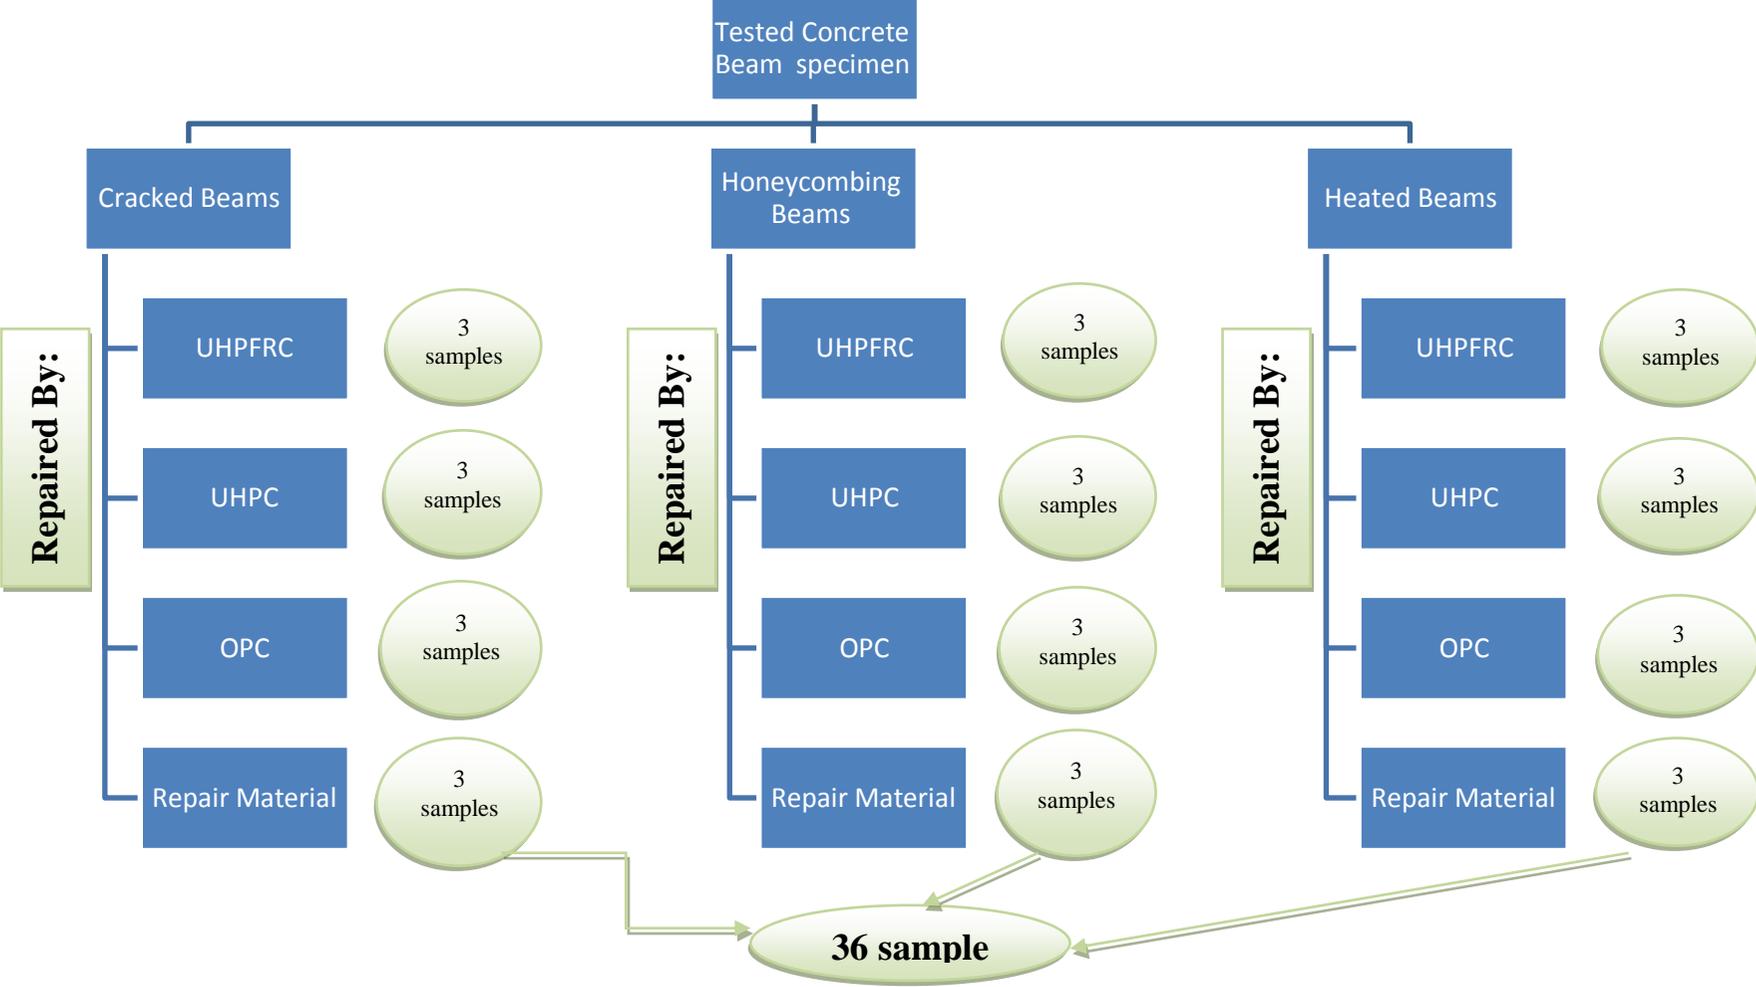
Figure 3-1: Testing Program Flow Chart

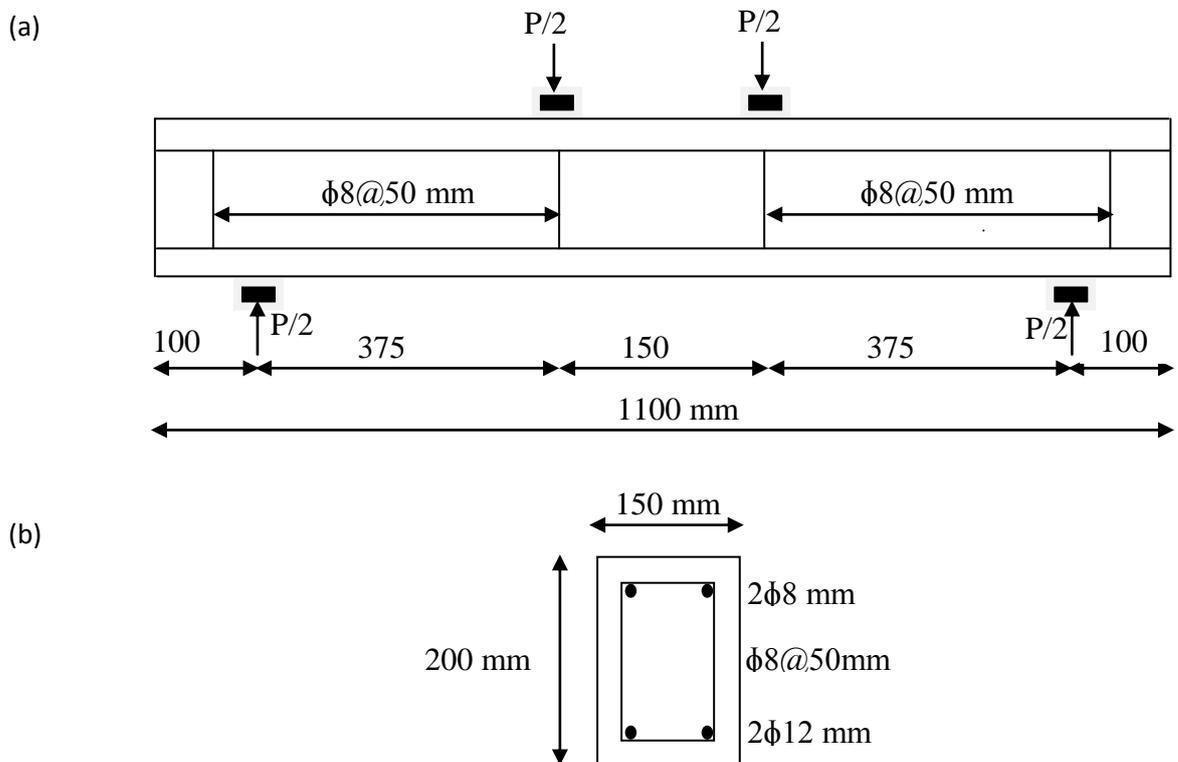
The beams are cast with concrete having a nominal cubic compressive strength of 250 kg/cm^2 .

Figure 3-2: Cracked Beam (a) layout and (b) Cross section

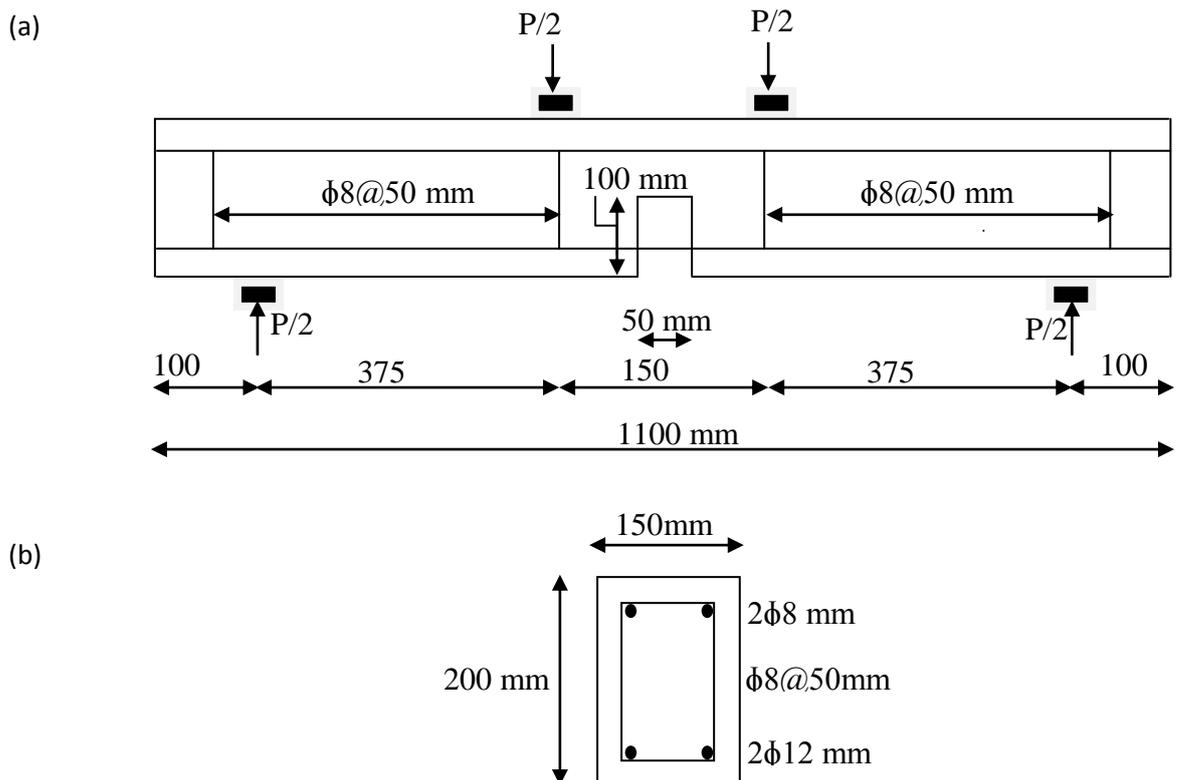
Semi full-scale tests are performed on 1.10 m long beams with a depth of 200 mm and a width of 150 mm, at mid of span in tension zone the section is empty from concrete by dimension (50mm width, 100mm highest, 150mm depth) as shown in Figure 3-3. Three beams are cast and reinforced with two bottom longitudinal rebar's ($\Phi=12$ mm), two top longitudinal rebar's ($\Phi=8$ mm) and, at the beam ends, stirrups having a diameter of 8 mm and a spacing of 50 mm. The ends of the bottom longitudinal rebar were anchorage to guarantee a good bonding and to avoid slipping out during loading. The beams are cast with concrete having a nominal cubic compressive strength of 250 kg/cm^2 .

Figure 3-3: Honeycomb Beam (a) layout and (b) Cross section

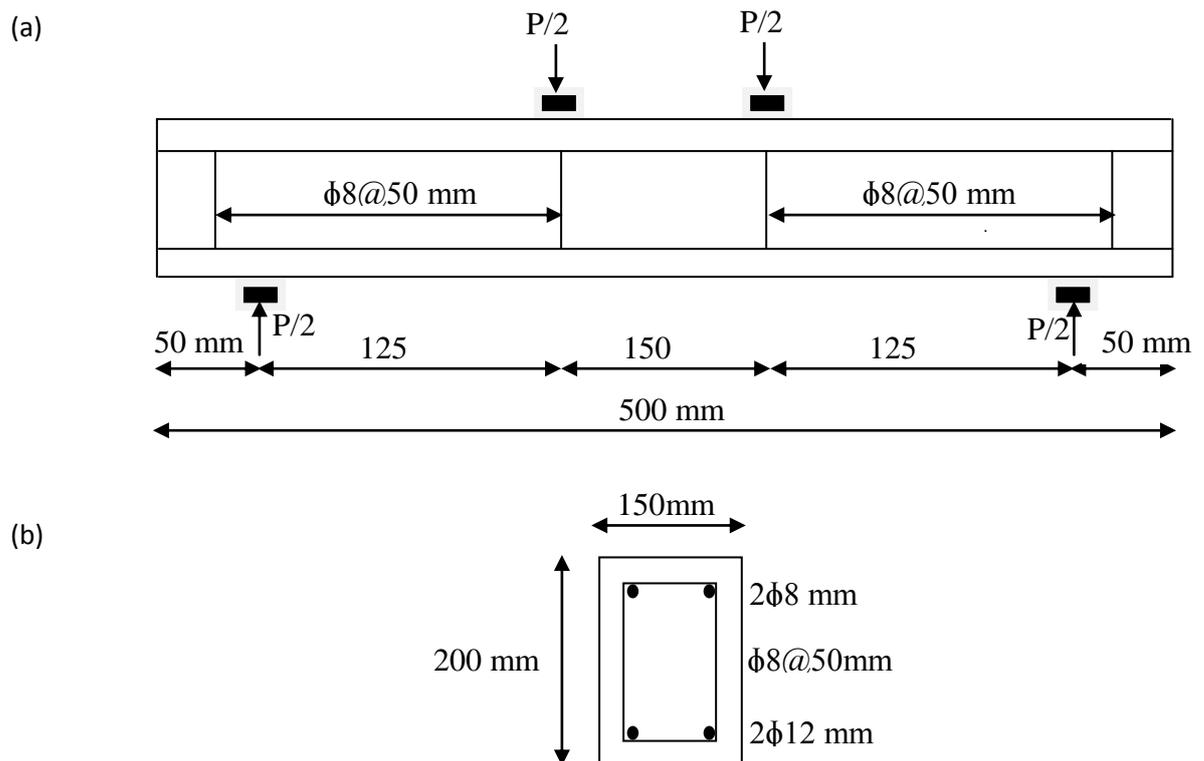
The heated beam geometry and its materials properties as shows in section 3.3.3, except that the beam length is 0.50 m as shown in Figure 3-4.

Figure 3-4: Heated Beam (a) layout and (b) Cross section

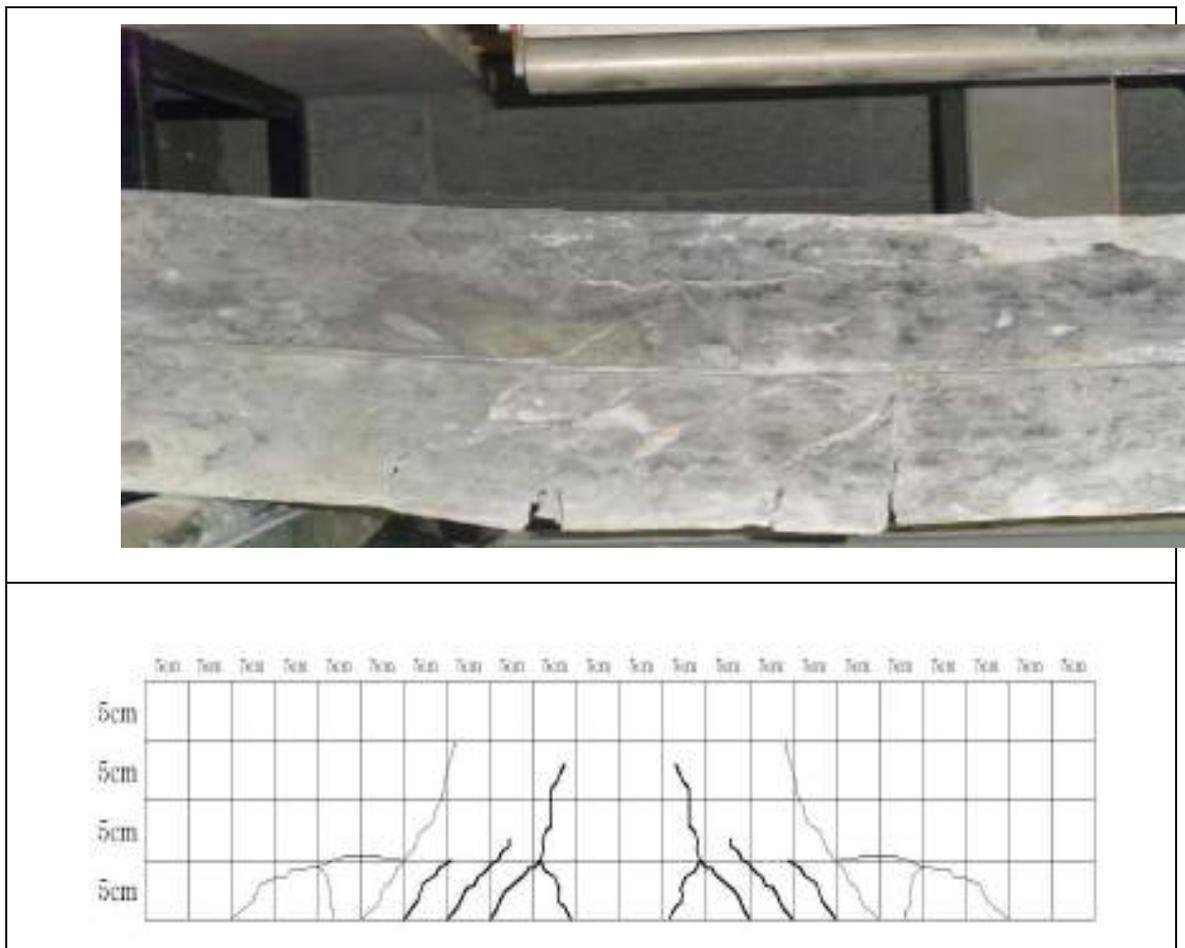
Crack patterns were taken and drawn to make a comparison with the repaired beams and shown in Figure 4-1.

Figure 4-1: Crack pattern of the control beams

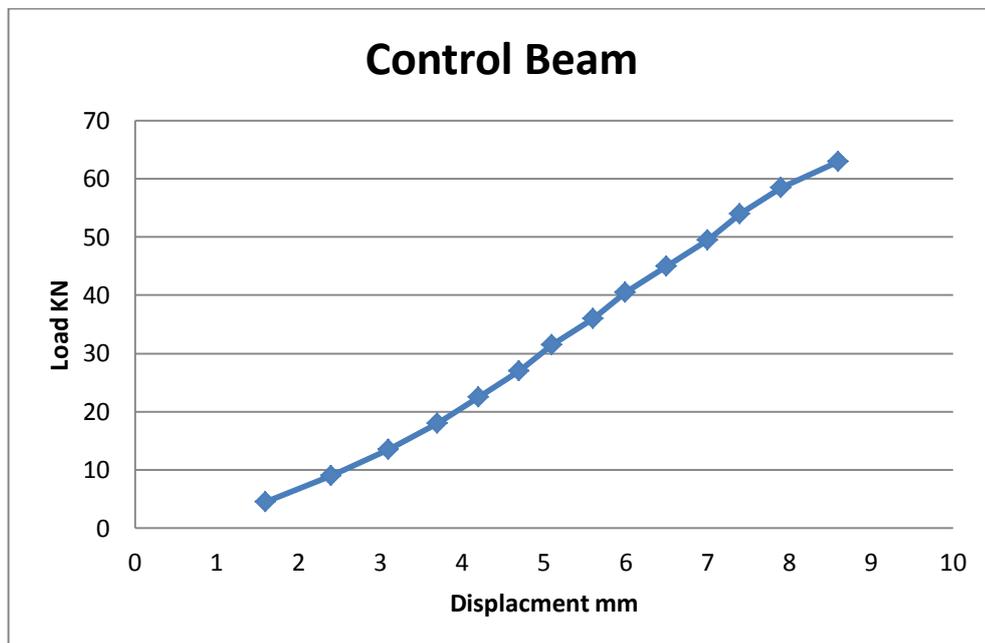
Load (KN)	Deflection (mm)
4.5	1.6
9	2.4
13.5	3.1
18	3.7
22.5	4.2
27	4.7
31.5	5.1
36	5.6
40.5	6
45	6.5
49.5	7
54	7.4
58.5	7.9
63	8.6

Figure 4-2: Mid - Span displacement

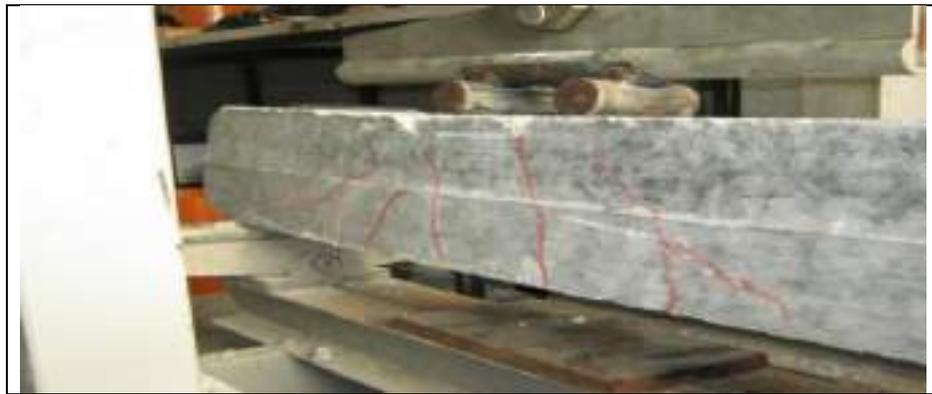
2nd Apply 80% of the factored load to the samples to cause cracking as shown in Figure 4-3:

Figure 4-3: Sample being cracked

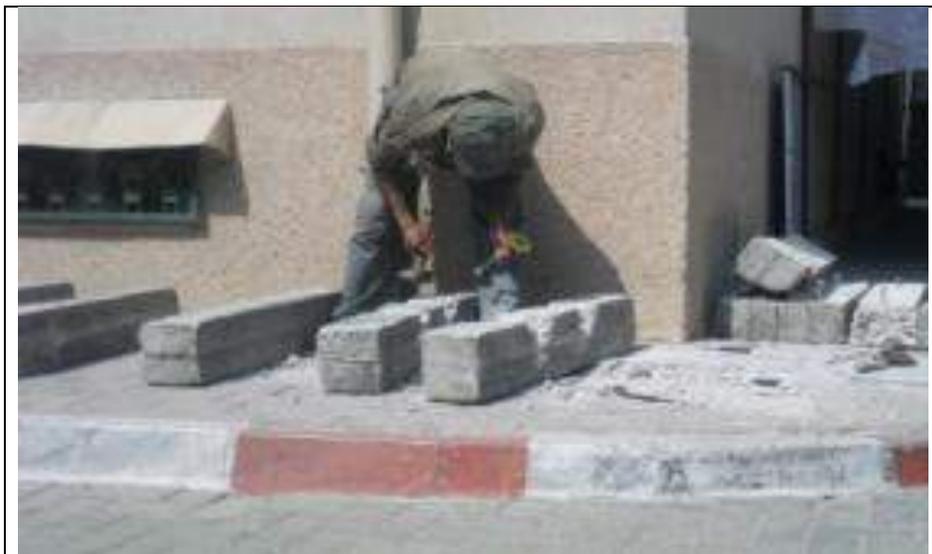
3rd Mark the cracks on the samples, widen the widths of the cracks to make it ready for applying the repair materials as, shown in Figure 4-4:

Figure 4-4: Crack Groves

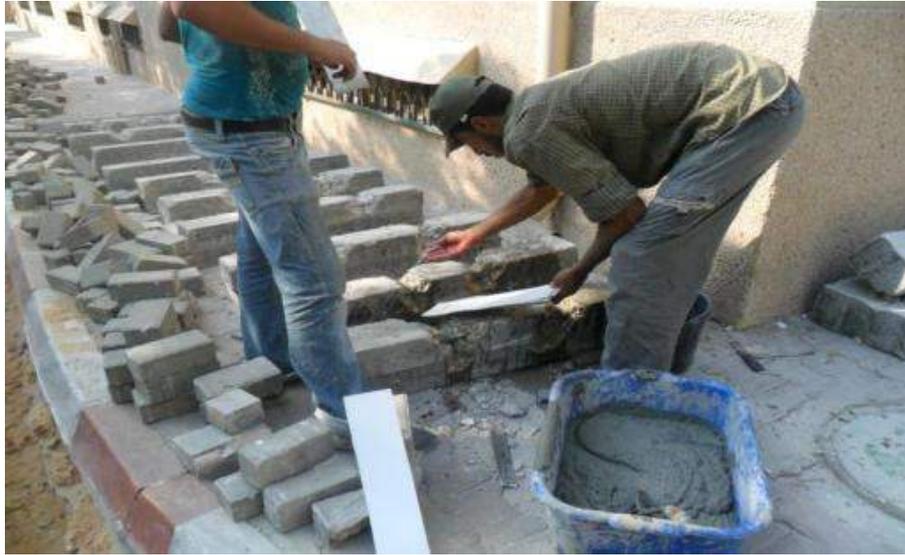
4th Wash the samples, shown in Figure 4-5.

Figure 4-5: Cleaning Samples by Water

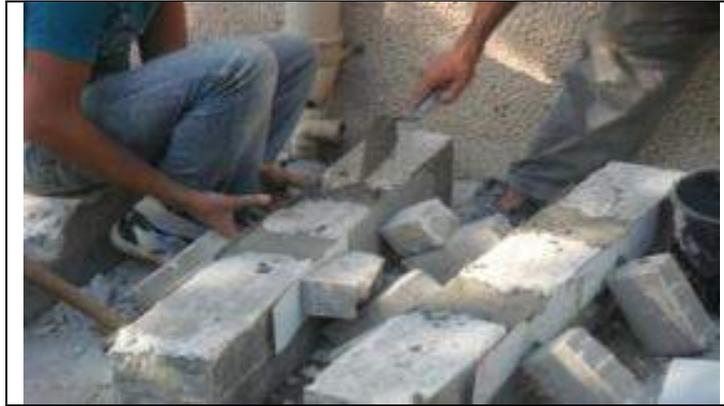
6th prepare the required material quantity of UHPC that enter in mixing, to be ready for application, see Figure 4-6:

Figure 4-6: Applying UHPC matrix to the Cracked beams

7thCure the samples after applying the UHPC matrix for 7 days.

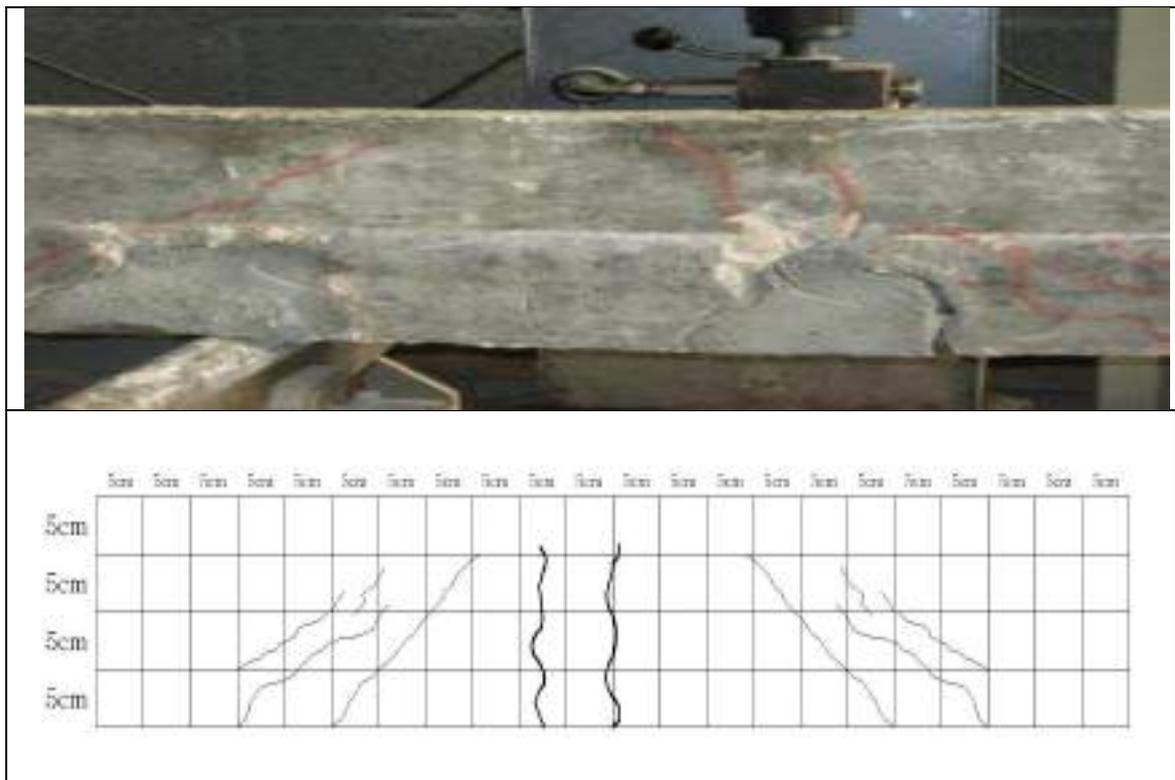
8thTest the samples repaired by UHPC and record the results, bearing capacity, crack pattern and deflection. (See Figure 4-7):

Figure 4-7: Cracked beam repaired by UHPC and its Crack Pattern

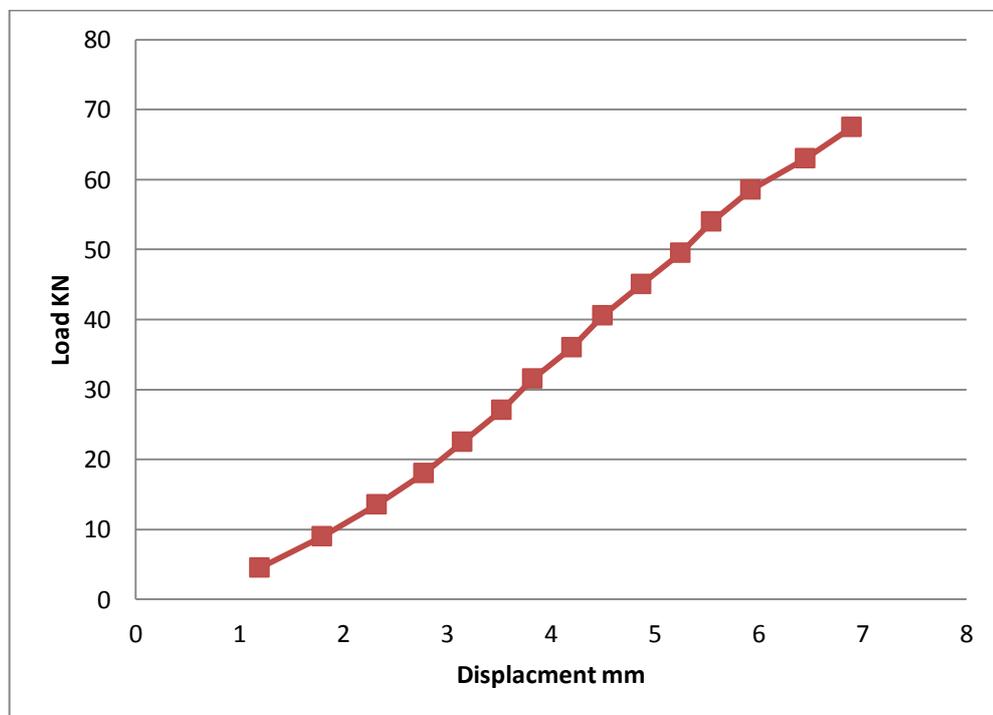
Load (KN)	Deflection (mm)
4.5	1.2
9	1.8
13.5	2.325
18	2.775
22.5	3.15
27	3.525
31.5	3.825
36	4.2
40.5	4.5
45	4.875
49.5	5.25
54	5.55
58.5	5.925
63	6.45
67.5	6.9

Figure 4-8: Displacement – load curve for cracked beams repaired using UHPC

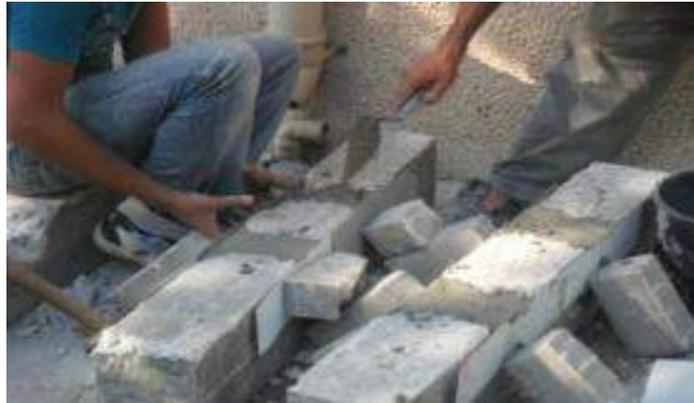
6th Prepare the required material quantity (see Figure 4-9):

Figure 4-9: Applying UHPFRC matrix to cracked beams

7th Cure the samples after applying the UHPFRC matrix for 7 days.

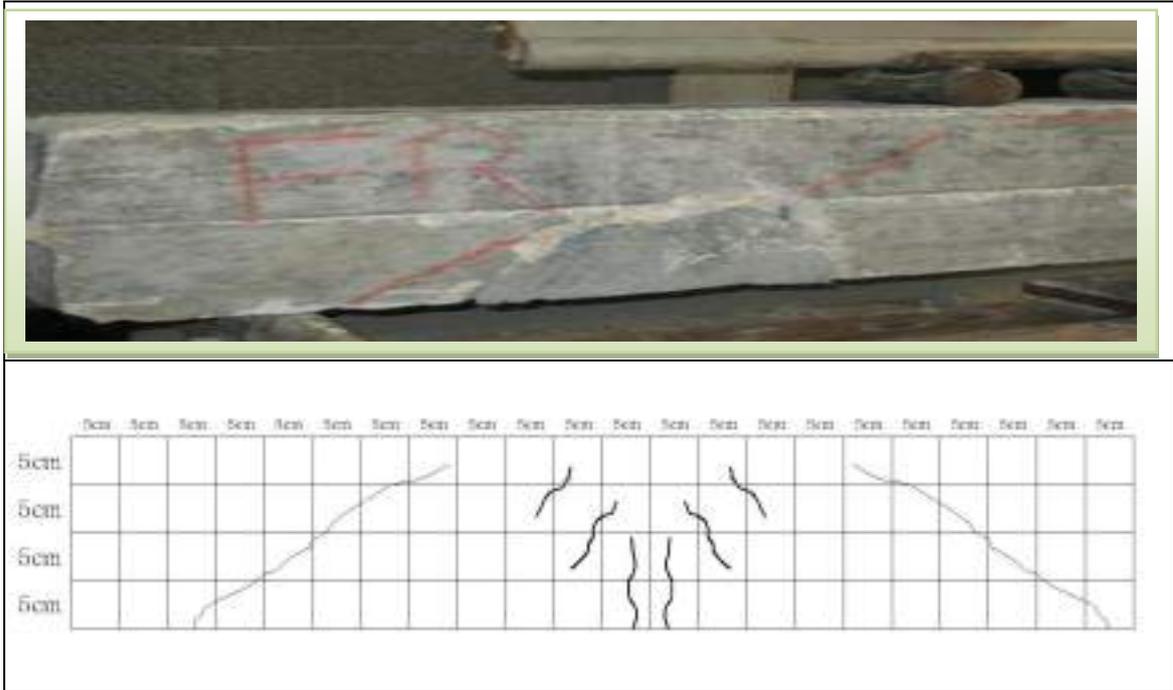
8th Test the sample repaired using UHPFRC and record the results, maximum capacity, crack pattern, and deflection. (See Figure 4-10).

Figure 4-10: Cracking pattern of cracked beams repaired by UHPFRC

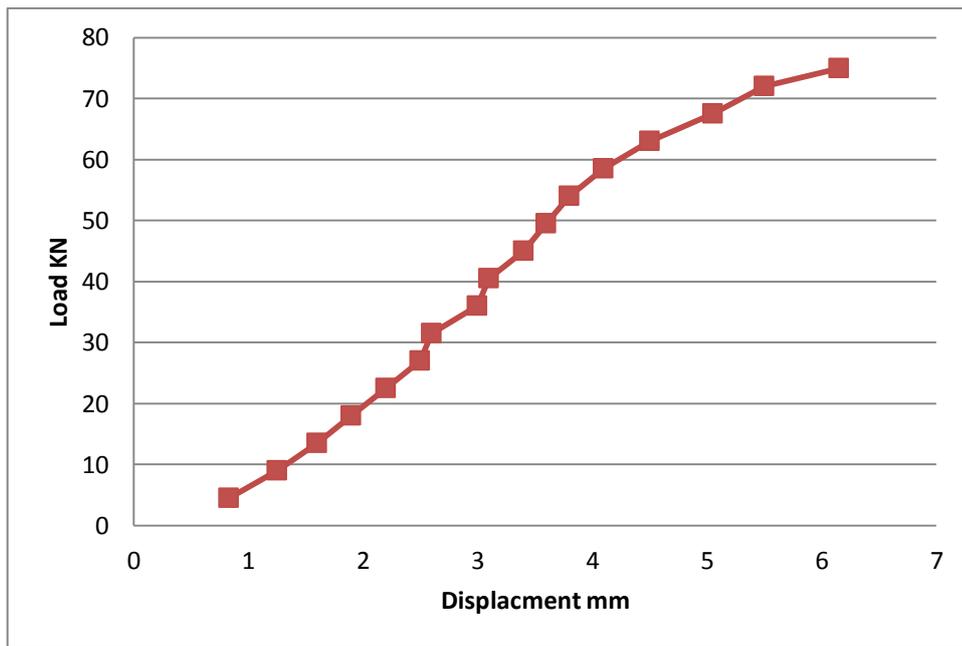
Load (KN)	Deflection (mm)
4.5	0.83
9	1.25
13.5	1.6
18	1.9
22.5	2.2
27	2.5
31.5	2.6
36	3
40.5	3.1
45	3.4
49.5	3.6
54	3.8
58.5	4.1
63	4.5
67.5	5.05
72	5.5
74.997	6.15

Figure 4-11: Displacement – load curve for cracked beam repaired by UHPFRC

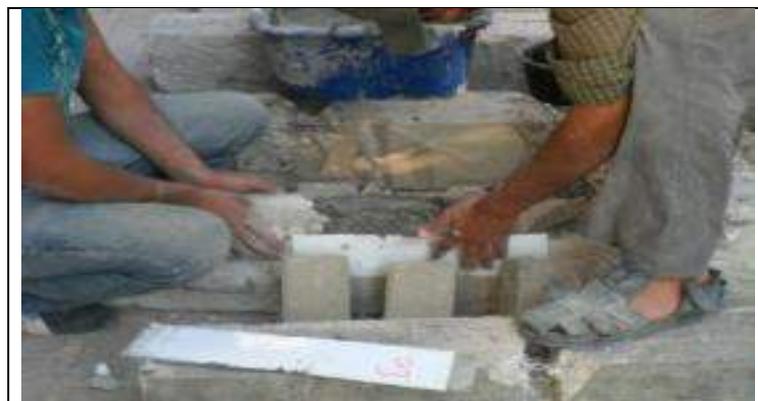
6th Prepare the required material quantity of OPC (see Figure 4-12)

Figure 4-12: Applying OPC matrix to Cracked beams

7th Cure the samples after applying the OPC matrix for 7 days.

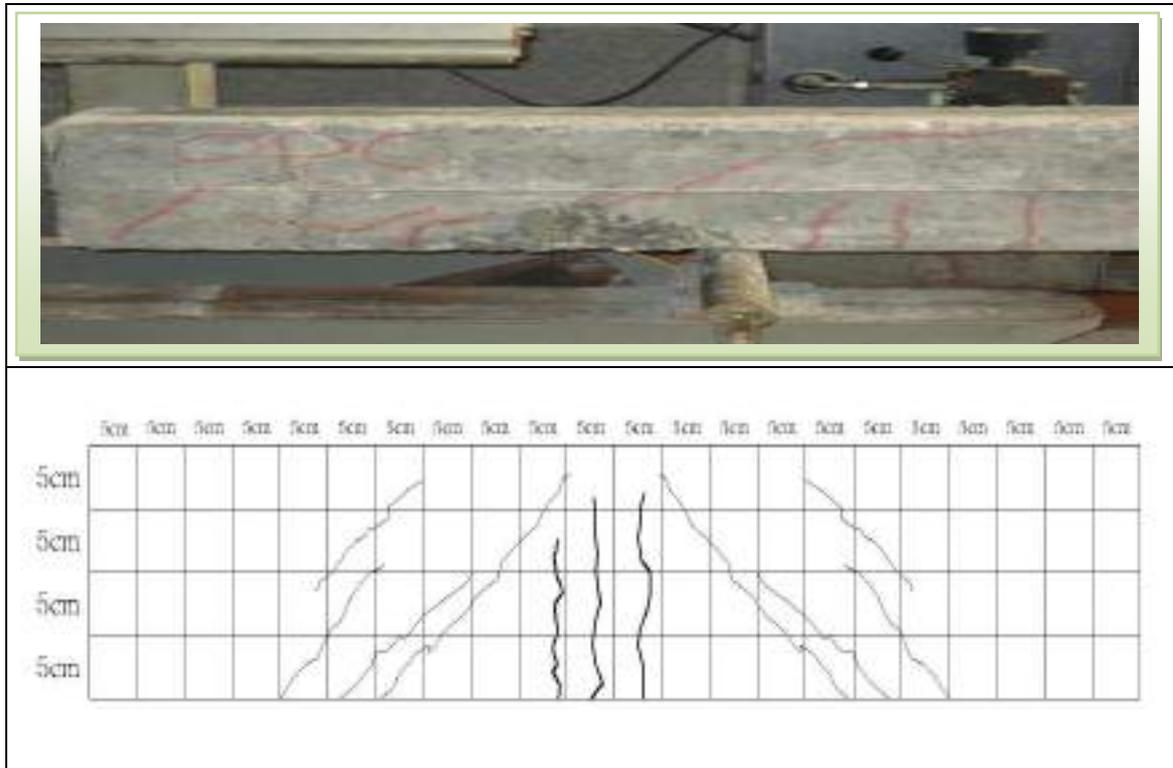
8th Test the samples repaired using OPC and record the results, bearing capacity, crack pattern, and deflection. (See Figure 4-13).

Figure 4-13: Cracking Pattern for cracked beams repaired by OPC

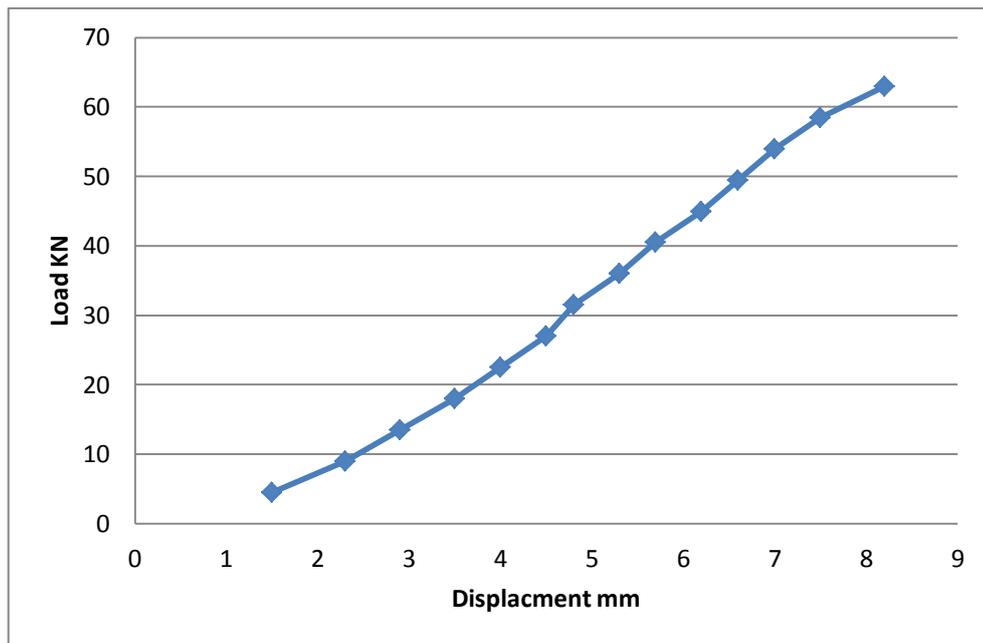
Load (KN)	Deflection (mm)
4.5	1.5
9	2.3
13.5	2.9
18	3.5
22.5	4
27	4.5
31.5	4.8
36	5.3
40.5	5.7
45	6.2
49.5	6.6
54	7
58.5	7.5
63	8.2

Figure 4-14: Displacement – load curve for cracked beam repaired by OPC

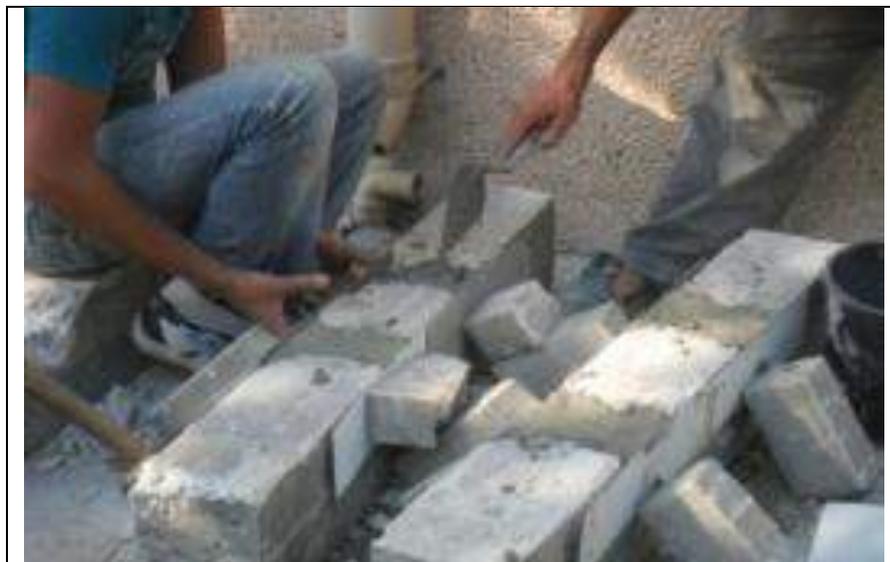
6th Prepare the required material quantity of SRM (see Figure 4-15):

Figure 4-15: Applying RM matrix to Cracked Beams

7th Cure the samples after applying the SRM matrix for 7 days.

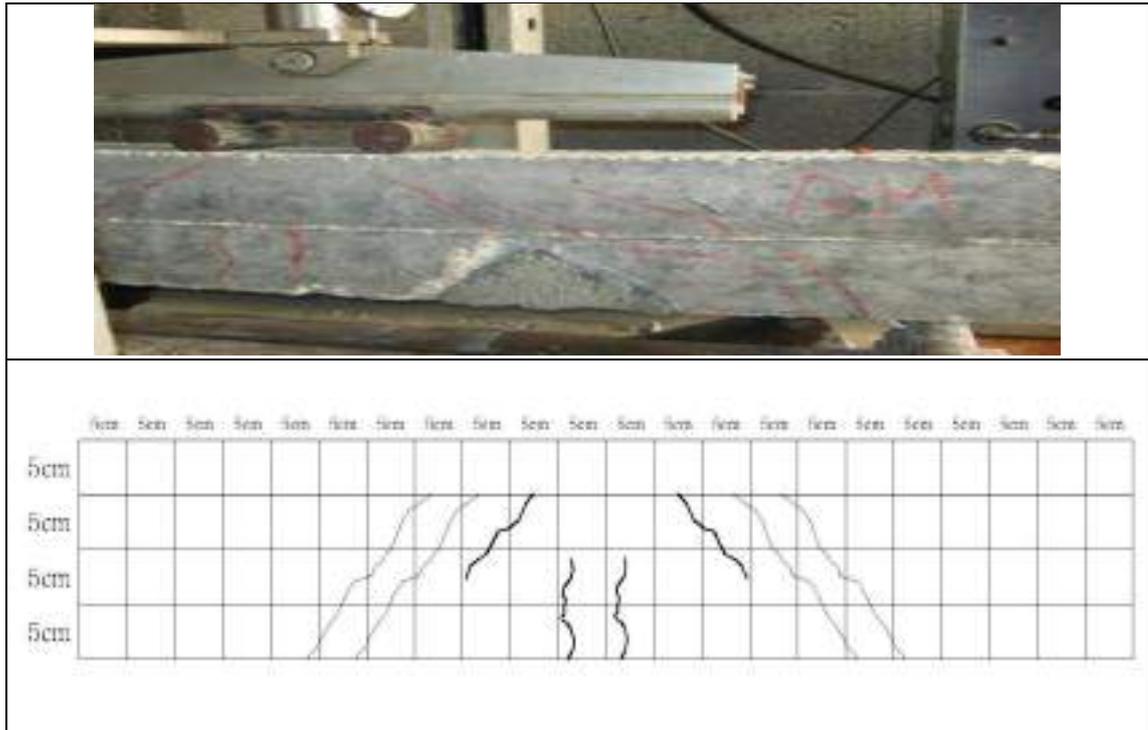
8th Test the samples repaired using SRM and record the results, bearing capacity, crack pattern, and deflection. (See Figure 4-16)

Figure 4-16: Cracking Pattern for cracked beams repaired by SRM

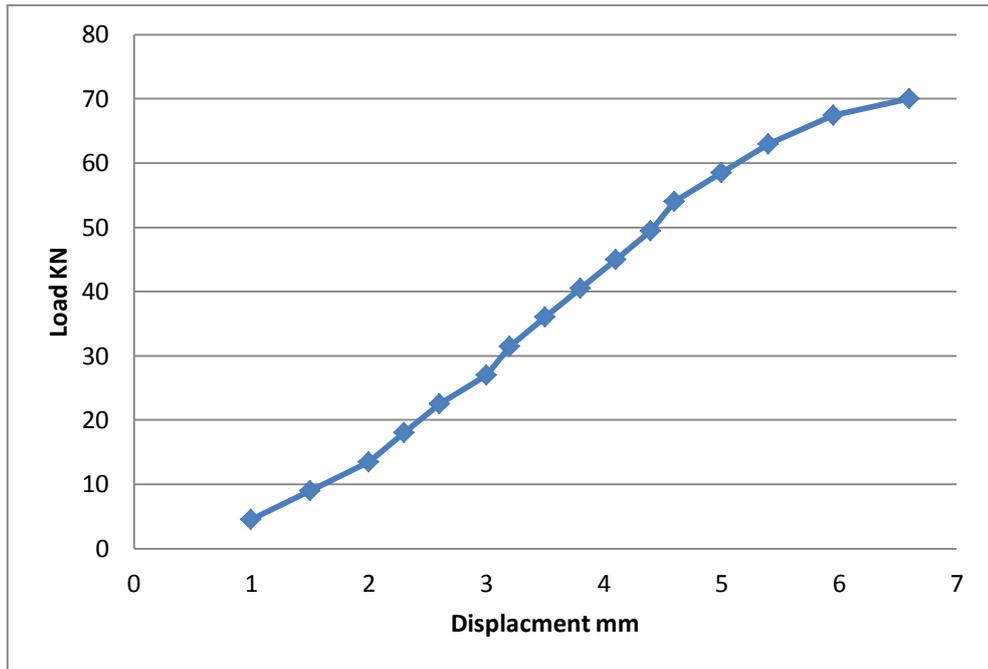
Load (KN)	Deflection (mm)
4.5	1
9	1.5
13.5	2
18	2.3
22.5	2.6
27	3
31.5	3.2
36	3.5
40.5	3.8
45	4.1
49.5	4.4
54	4.6
58.5	5
63	5.4
67.5	5.95
69.9975	6.6

Figure 4-17: Displacement – load curve for cracked beam repaired by SRM

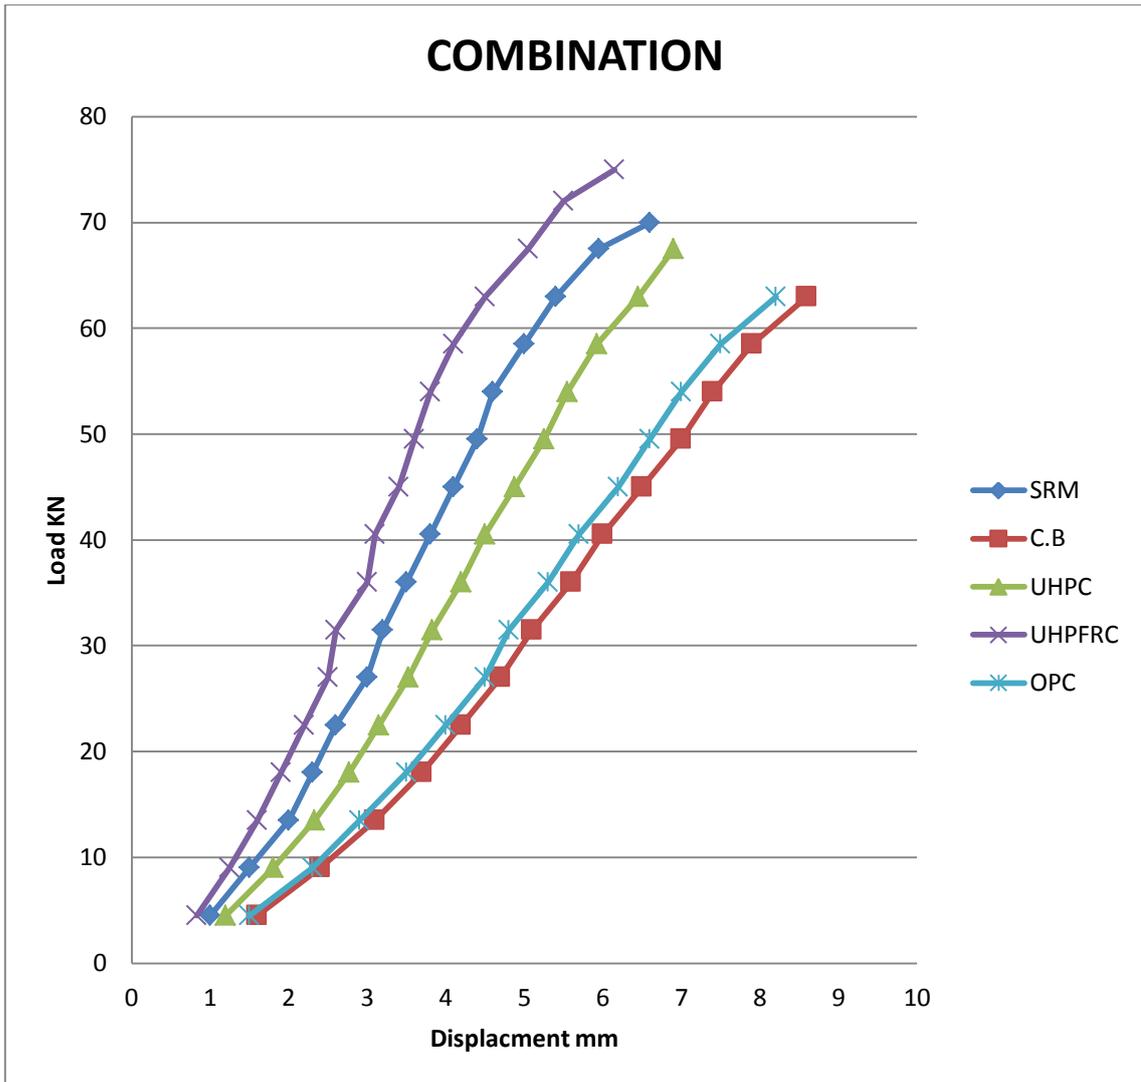
Load (KN)	Deflection (mm) of control beam (C.B)	Deflection (mm) of Repaired beam by			
		UHPC	UHPFRC	OPC	SRM
4.5	1.6	1.2	0.83	1.5	1
9	2.4	1.8	1.25	2.3	1.5
13.5	3.1	2.325	1.6	2.9	2
18	3.7	2.775	1.9	3.5	2.3
22.5	4.2	3.15	2.2	4	2.6
27	4.7	3.525	2.5	4.5	3
31.5	5.1	3.825	2.6	4.8	3.2
36	5.6	4.2	3	5.3	3.5
40.5	6	4.5	3.1	5.7	3.8
45	6.5	4.875	3.4	6.2	4.1
49.5	7	5.25	3.6	6.6	4.4
54	7.4	5.55	3.8	7	4.6
58.5	7.9	5.925	4.1	7.5	5
63	8.6	6.45	4.5	8.2	5.4
67.5	---	6.90	5.05	---	5.95
72	---	---	5.5	---	---
75	---	---	6.15	---	---

Figure 4-18: Load - Deflection Relationship

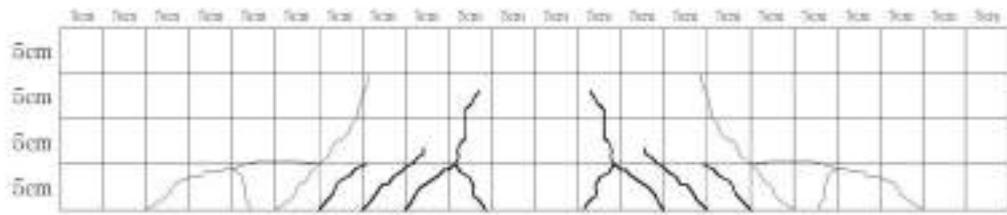
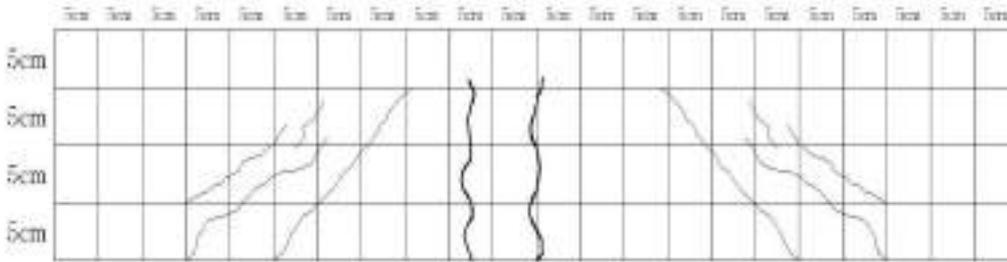
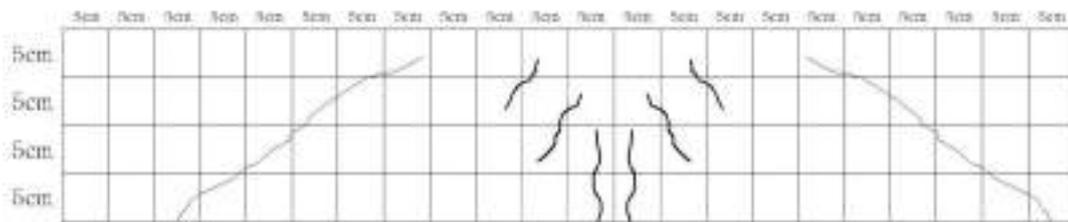
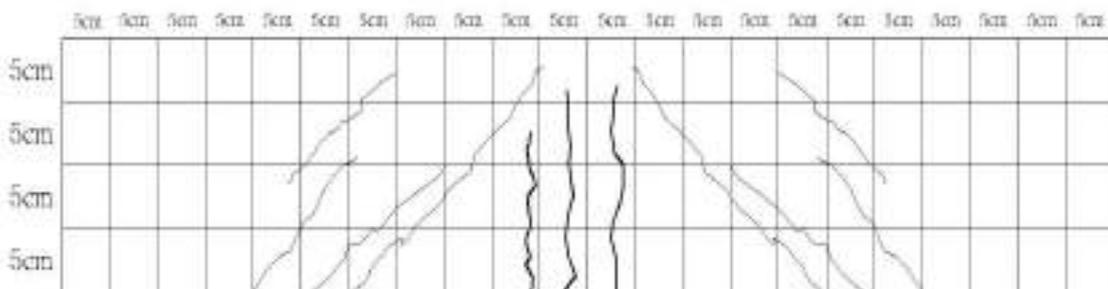
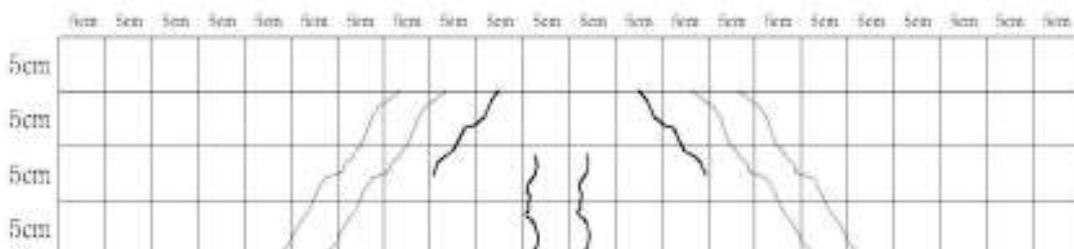
Improvement of crack pattern for beams repaired by UHPFRC and SRM that refer to good bonding between the repair materials and old concrete. The crack pattern of beams repaired by OPC and UHPC are similar cracking pattern of control beam that refers to less bonding between these materials and old concrete.

Crack pattern of control beams

Crack pattern of UHPC beams

Crack pattern of UHPFRC beams

Crack pattern of OPC beams

Crack pattern of SRM beams

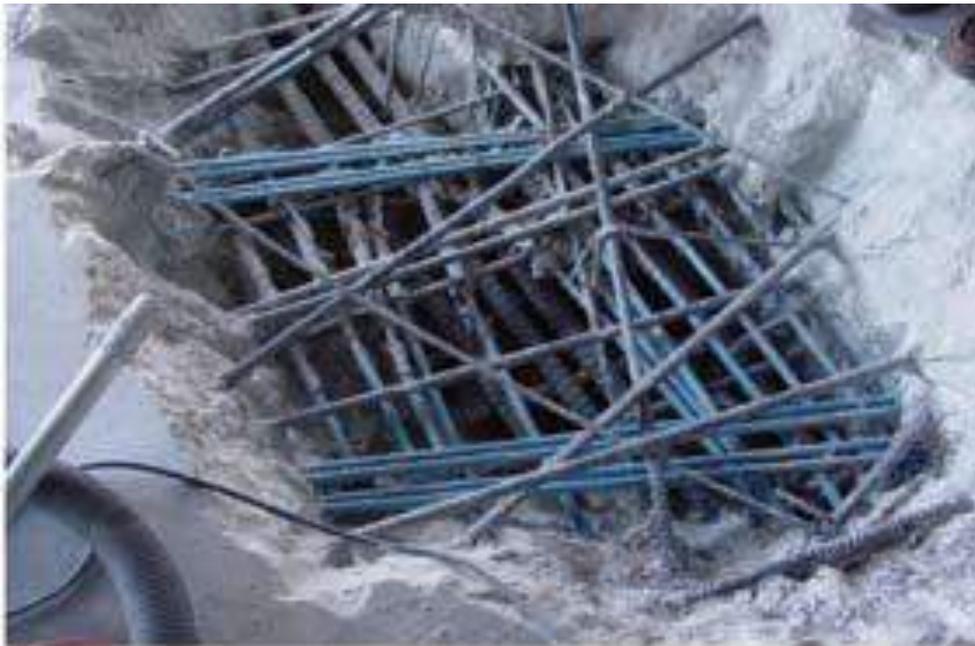
Reinforced concrete is a combination of concrete (cement and aggregates) and reinforcing steel. The cement mortar portion of this composite material (approx 25% of the concrete) acts as a paste or glue that binds aggregates together. When properly designed and placed these three materials create a unique composite that can be cast into thousands of different infrastructure applications. In order to have a reinforced concrete beam, column, slab or wall function properly, the concrete must be properly consolidated in the forms, i.e. it must completely encapsulate the reinforcement and be free of voids or "honeycombs". Voids are completely empty or hollow spaces in the form in which no concrete exists. Honeycombs based on a Portland Cement Association definition, are voids left in concrete due to failure of the cement mortar to effectively fill all the spaces between the coarse aggregate particles. Severe honeycombs (sometimes known as rock pockets) occur when an excessive amount of aggregate is found without the presence of cement paste. (See Figure 5-1).

Figure 5-1: Honeycomb in a column due to excessive lift depth

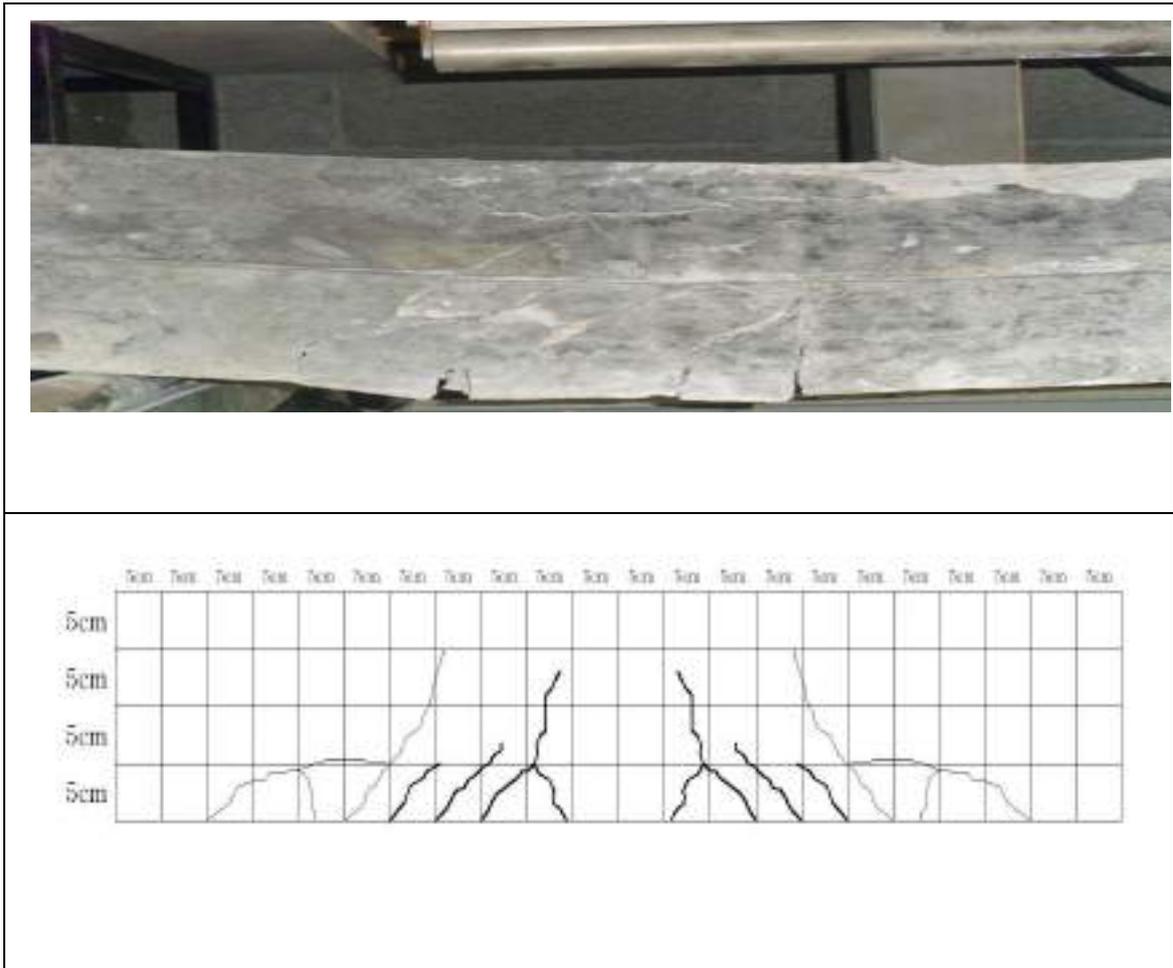
Crack pattern were taken and drawn to make a comparison with those of the repaired beams (see Figure 5-2).

Figure 5-2: Crack pattern of control beams

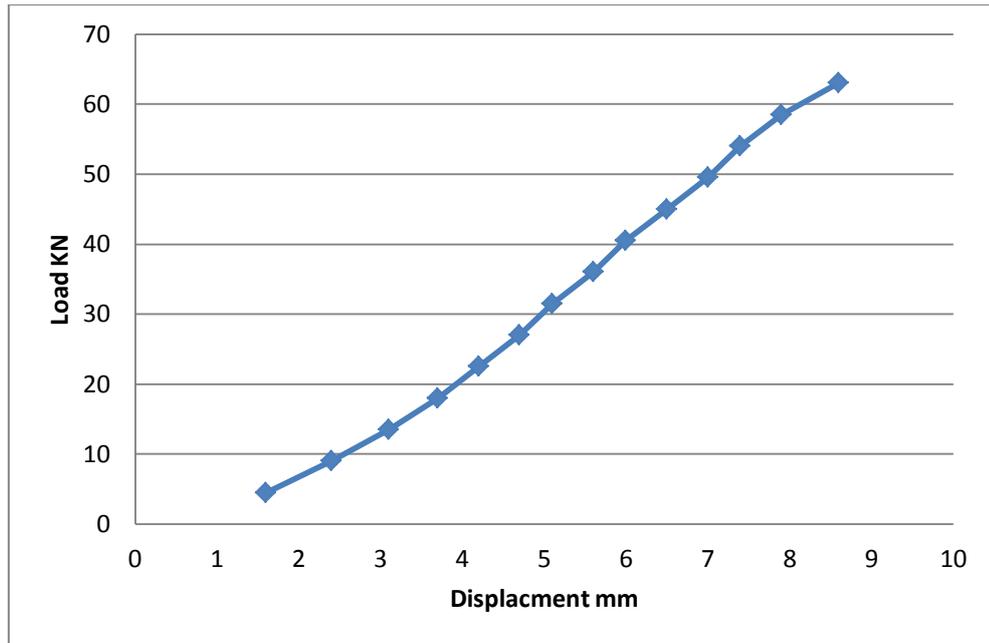
load (KN)	Deflection (mm)
4.5	1.6
9	2.4
13.5	3.1
18	3.7
22.5	4.2
27	4.7
31.5	5.1
36	5.6
40.5	6
45	6.5
49.5	7
54	7.4
58.5	7.9
63	8.6

Figure 5-3: Mid-span Displacement

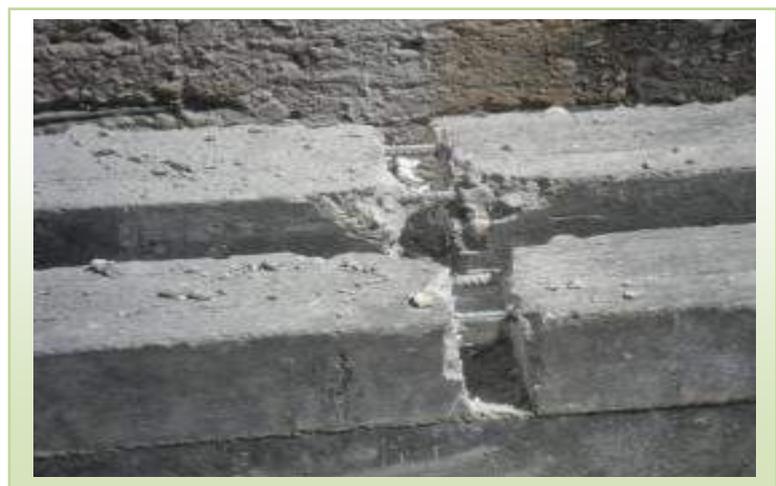
2nd Clean the samples after curing time to be ready for applying a cementitious material, as shown in Figure 5-4:

Figure 5-4: Cleaning the honeycomb samples

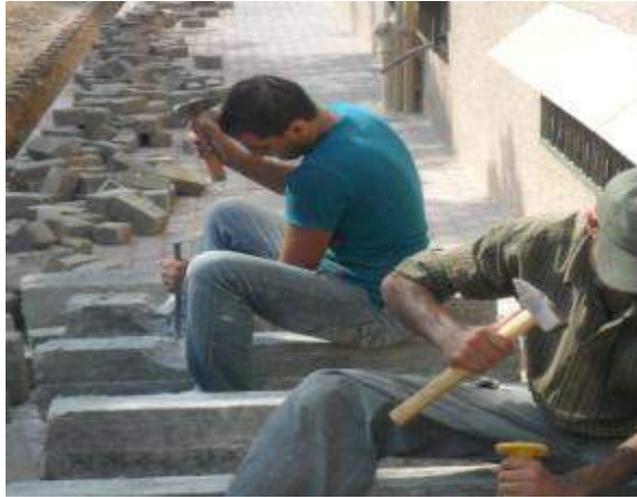
3rd Chip the honeycomb area to make a good bond with the repair material. This step appears in Figure 5-5:

Figure 5-5: Hand Blasting Honeycomb Area

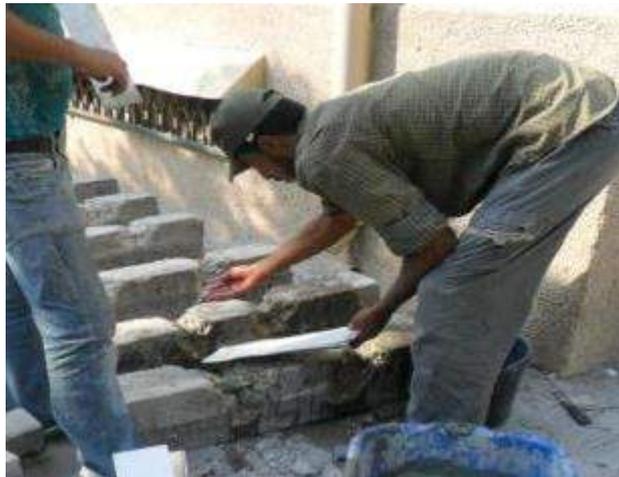
4th Wash the samples after chipping process to clean the sample from any loose aggregate see Figure 5-6.

Figure 5-6: chipping the sample by water
