**Strengthening and Repair of RC Beams with Cementitious Repair
Materials**

The Islamic University of Gaza
Deanship of Higher Studies
Faculty of Engineering
Civil Engineering Department
Design and Rehabilitation of
Structures.

A Thesis Submitted in Partial Fulfillment of the Requirements for Degree of
Master of Science in Civil Engineering -Rehabilitation and Design of Structures

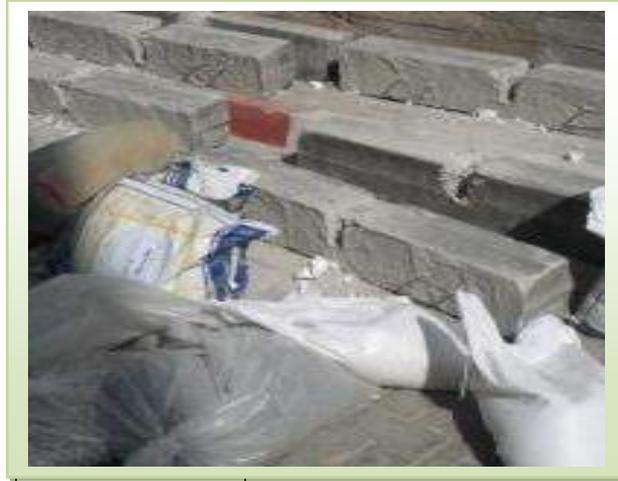
6th Prepare the required amount of UHPC, see Figure 5-7.

Figure 5-7: Applying UHPC matrix on Honeycombed beams

7th Cure the samples after applying the UHPC matrix for 7 days.

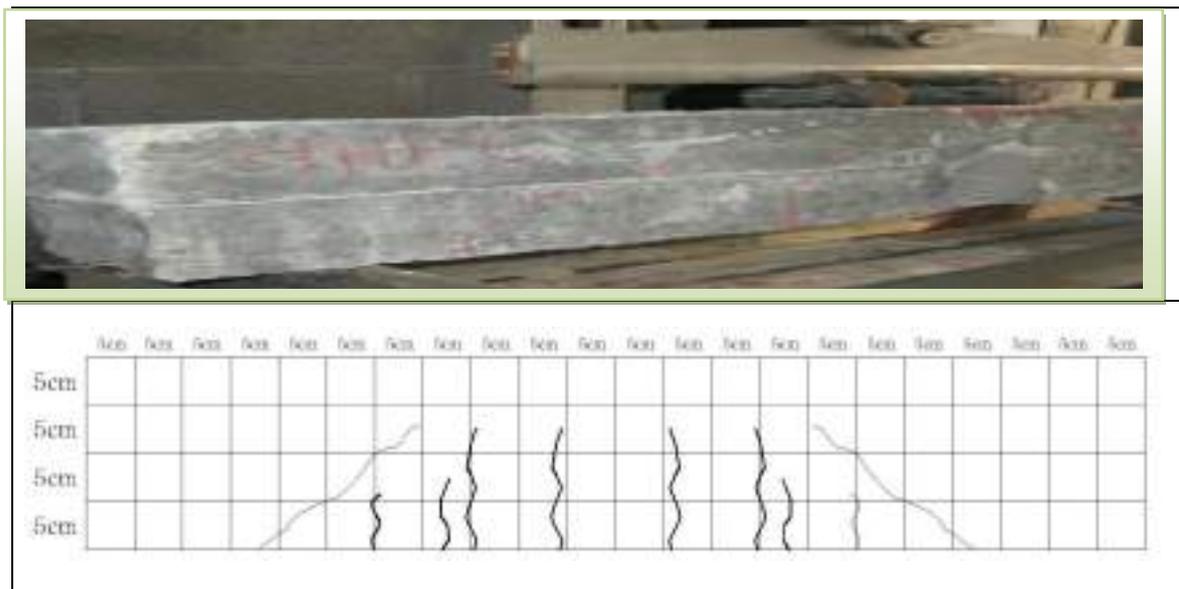
8th Test the samples and record the results including, flexural capacity, crack pattern, and deflection. See Figure 5-8:

Figure 5-8: Honeycombed beam repaired, and its crack pattern

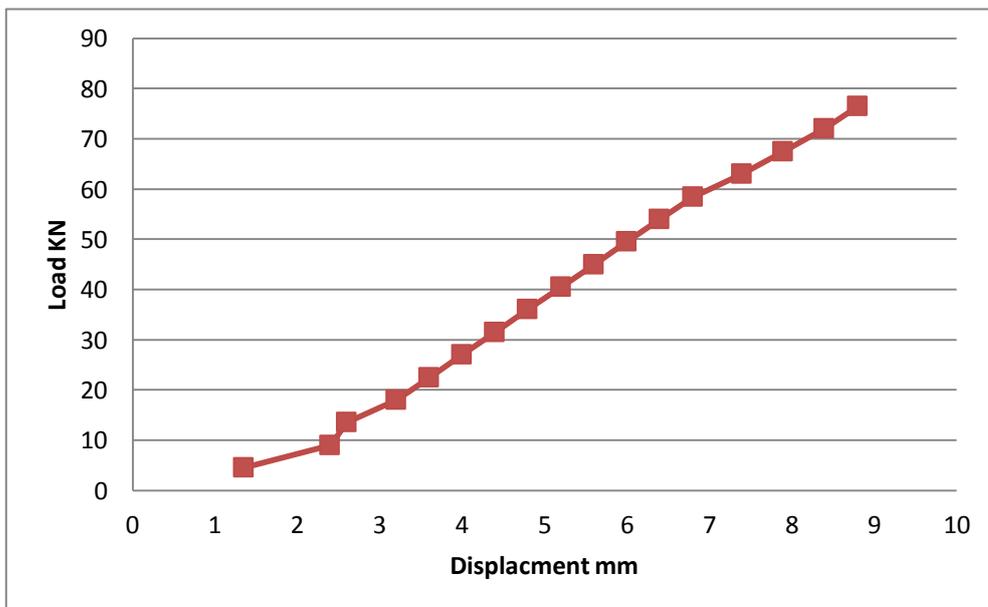
Load (KN)	Deflection (mm)
4.5	1.35
9	2.4
13.5	2.6
18	3.2
22.5	3.6
27	4
31.5	4.4
36	4.8
40.5	5.2
45	5.6
49.5	6
54	6.4
58.5	6.8
63	7.4
67.5	7.9
72	8.4
76.5	8.8

Figure 5-9: Displacement – load curve for honeycombed beams repaired by UHPC

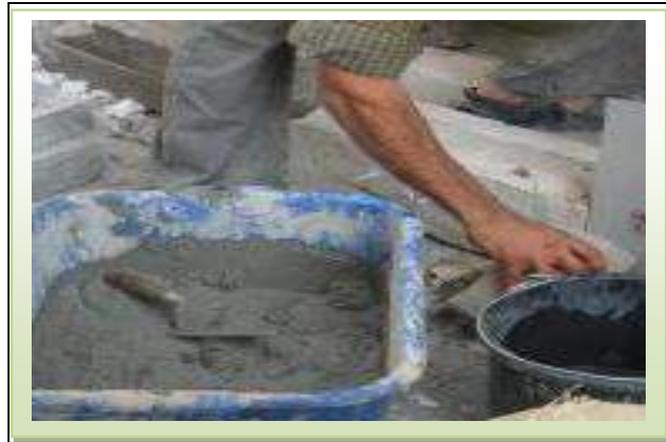
6th Prepare the required amount of UHPFRC, See Figure 5-10.

Figure 5-10: Applying UHPFRC matrix to Honeycombed beams

7th Cure the samples after applying the UHPFRC matrix for 7 days.

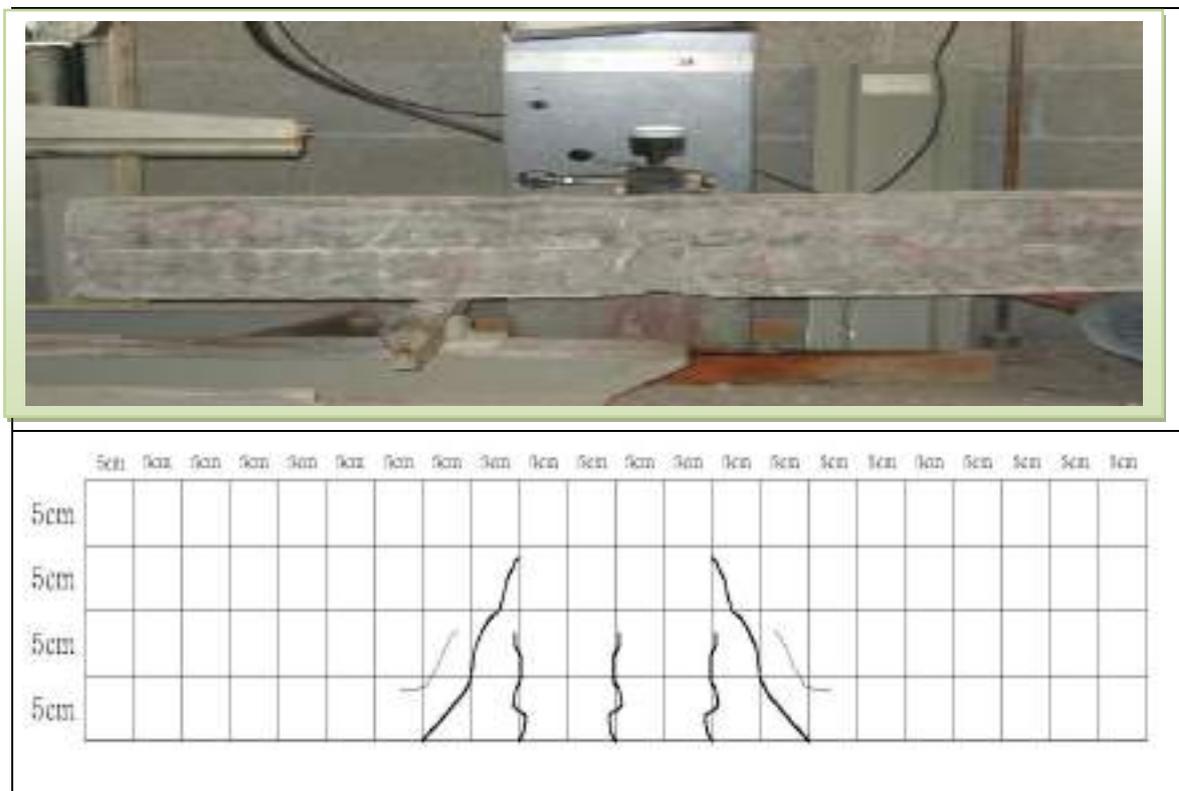
8th Test the sample repaired and record the results including, flexural capacity, crack pattern, and deflection. See Figure 5-11.

Figure 5-11: Honeycombed beams repaired, and its crack pattern

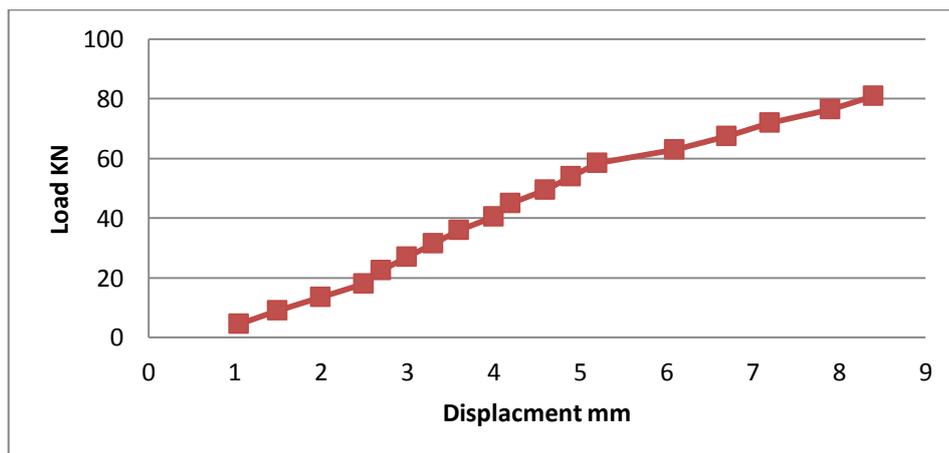
Load (KN)	Deflection (mm)
4.5	1.05
9	1.5
13.5	2
18	2.5
22.5	2.7
27	3
31.5	3.3
36	3.6
40.5	4
45	4.2
49.5	4.6
54	4.9
58.5	5.2
63	6.1
67.5	6.7
72	7.2
76.5	7.9
81	8.4

Figure 5-12: Displacement – load curve for honeycombed beams repaired by UHPFRC

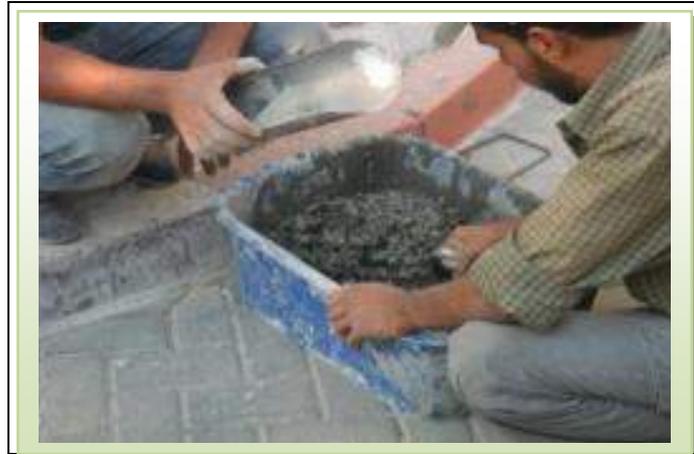
6th Prepare the required amount of OPC, See Figure 5-13.

Figure 5-13: Applying OPC matrix on honeycombed beams

7th Cure the samples after applying the OPC matrix for 7 days.

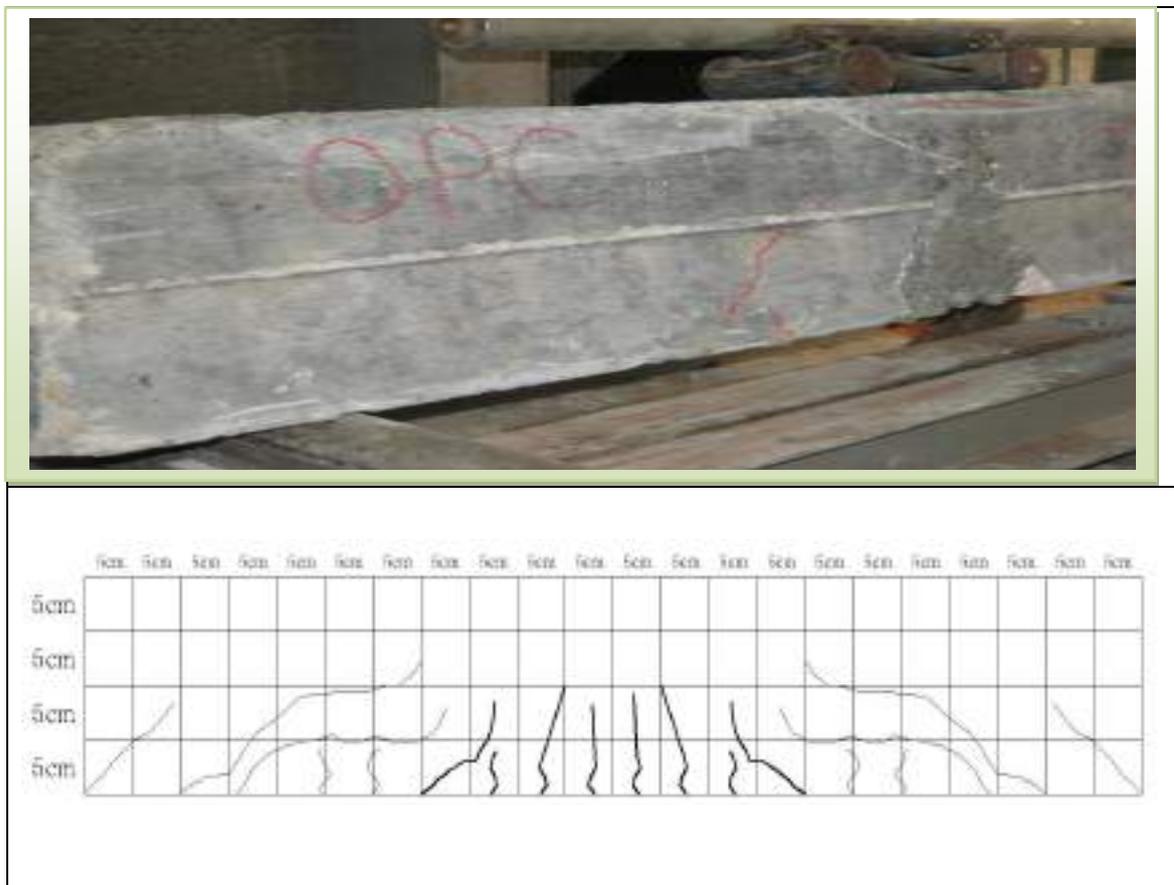
8th Test the samples repaired and record the results including, flexural capacity, crack pattern, and deflection. See Figure 5-14.

Figure 5-14: Honeycomb beam repaired by OPC tested, and its crack pattern

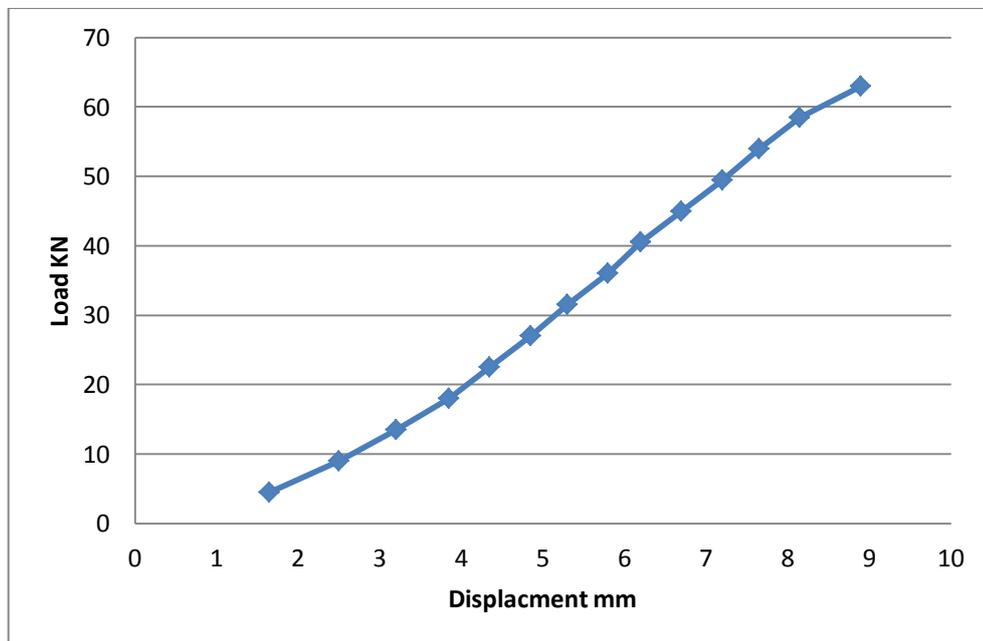
Load (KN)	Deflection (mm)
4.5	1.65
9	2.5
13.5	3.2
18	3.85
22.5	4.35
27	4.85
31.5	5.3
36	5.8
40.5	6.2
45	6.7
49.5	7.2
54	7.65
58.5	8.15
63	8.9

Figure 5-15: Displacement – load curve for Honeycombed beam repaired by OPC

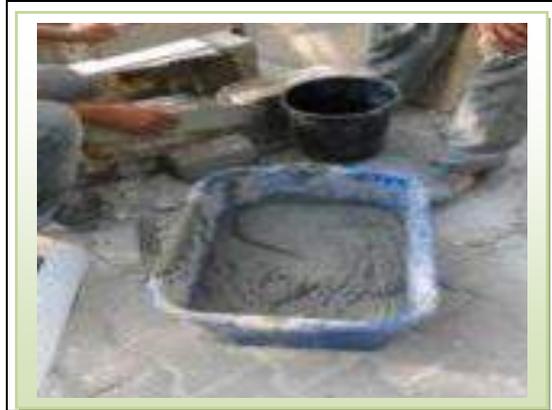
6th Prepare the required amount of SRM, See Figure 5-16.

Figure 5-16: Applying RM matrix on Honeycombed beam

7th Cure the samples after applying the RM matrix for 7 days.

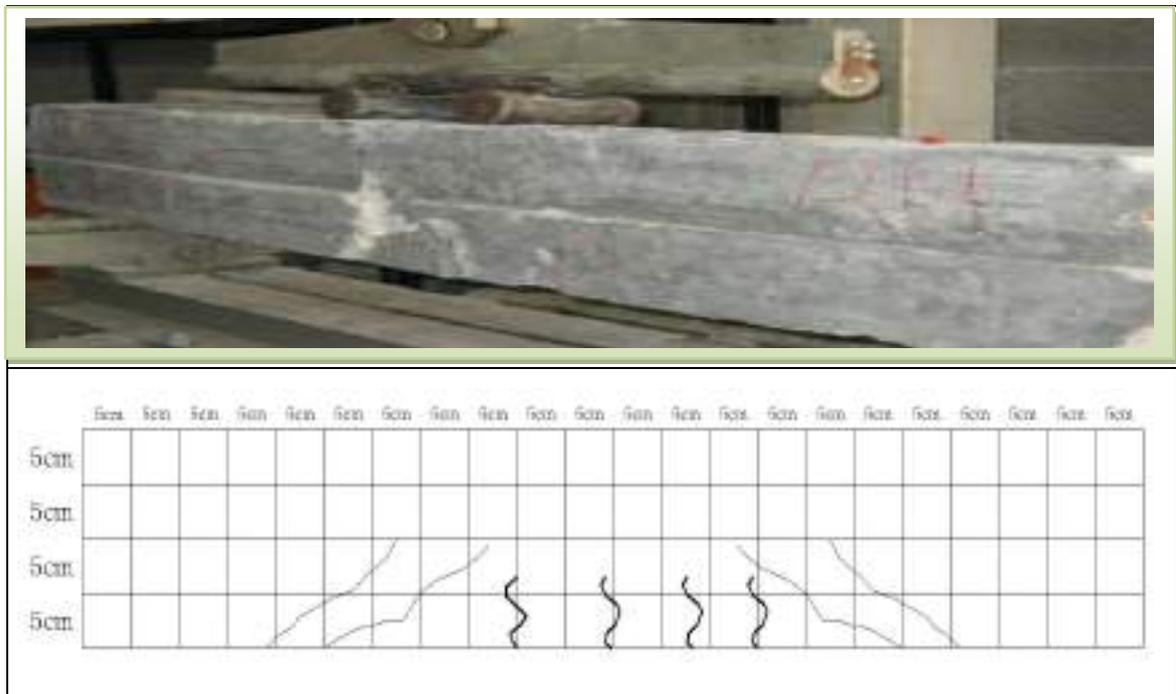
8th Test the samples repaired using RM and record the results, bearing capacity, crack pattern, and deflection. See Figure 5-17.

Figure 5-17: Honeycomb beams repaired by SRM tested, and its crack pattern

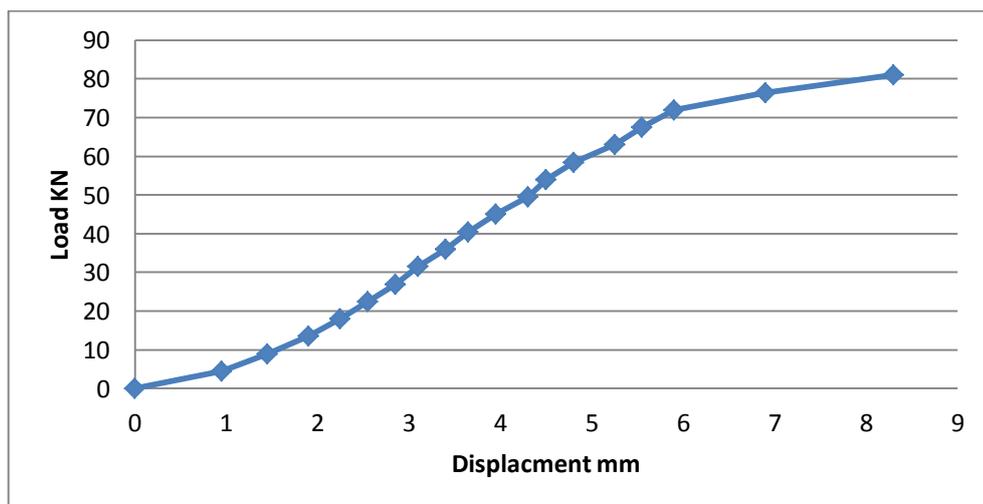
Load (KN)	Deflection (mm)
4.5	0.95
9	1.45
13.5	1.9
18	2.25
22.5	2.55
27	2.85
31.5	3.1
36	3.4
40.5	3.65
45	3.95
49.5	4.3
54	4.8
58.5	5.45
63	5.25
67.5	5.55
72	5.9
76.5	6.90
81	8.3

Figure 5-18: Displacement – load curve for Honeycombed beams repaired by SRM

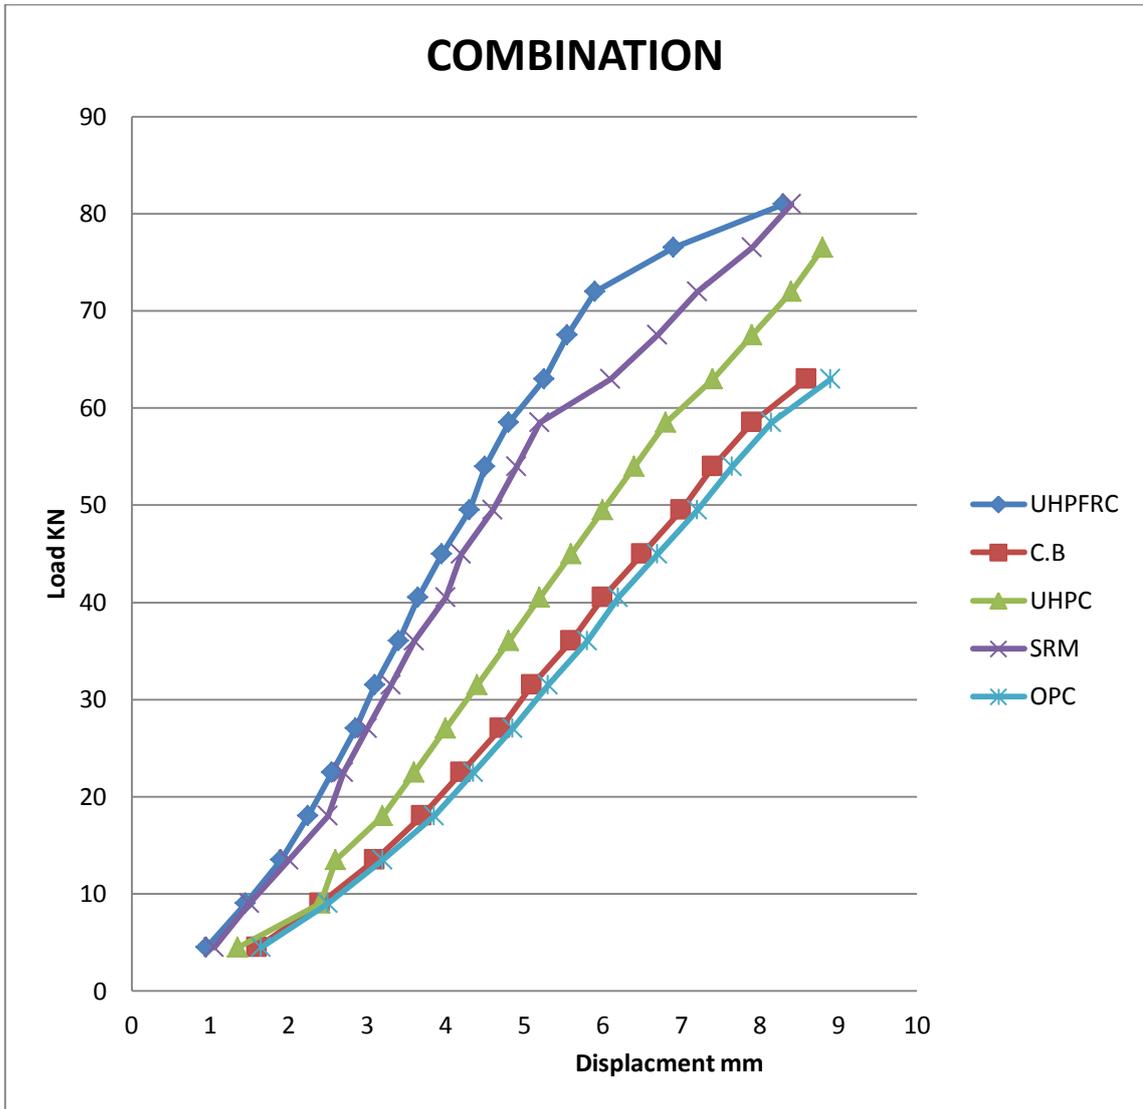
Load (KN)	Deflection (mm) of control beam (C.B)	Deflection (mm) of beams repaired by			
		UHPC	UHPFRC	OPC	SRM
4.5	1.6	1.35	1.05	1.65	0.95
9	2.4	2.4	1.5	2.5	1.45
13.5	3.1	2.6	2	3.2	1.9
18	3.7	3.2	2.5	3.85	2.25
22.5	4.2	3.6	2.7	4.35	2.55
27	4.7	4	3	4.85	2.85
31.5	5.1	4.4	3.3	5.3	3.1
36	5.6	4.8	3.6	5.8	3.4
40.5	6	5.2	4	6.2	3.65
45	6.5	5.6	4.2	6.7	3.95
49.5	7	6	4.6	7.2	4.3
54	7.4	6.4	4.9	7.65	4.5
58.5	7.9	6.8	5.2	8.15	4.8
63	8.6	7.4	6.1	8.9	5.25
67.5	---	7.9	6.7	---	5.55
72	---	---	7.2	---	5.9
75	---	---	7.9	---	6.9
81	---	---	8.4	---	8.3

Figure 5-19: Load - deflection relationship

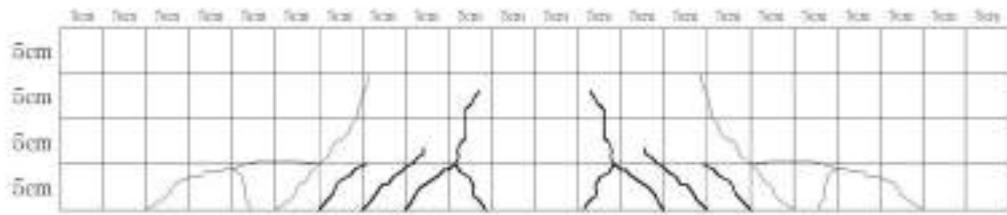
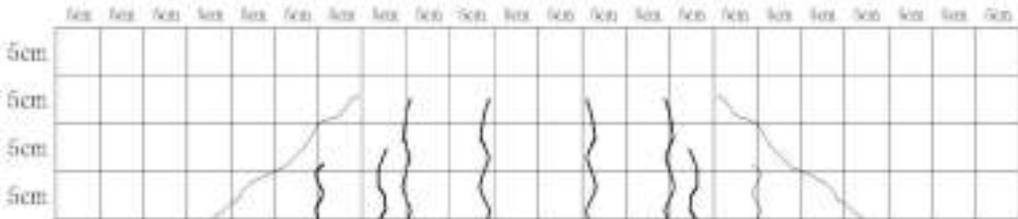
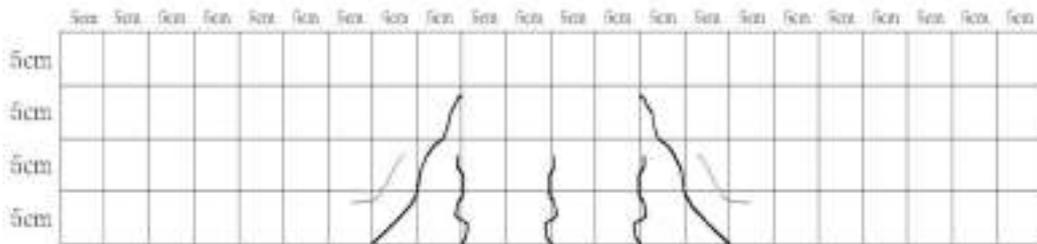
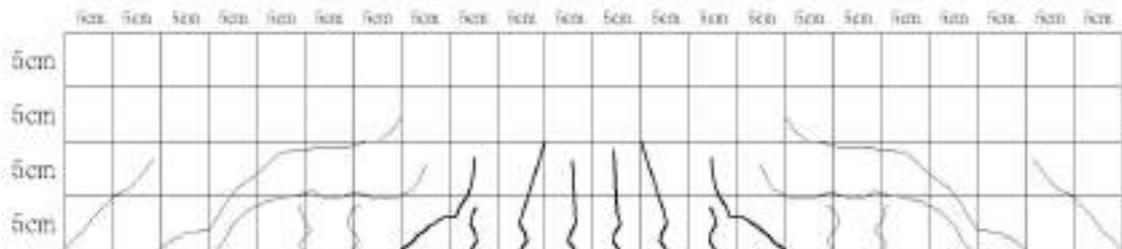
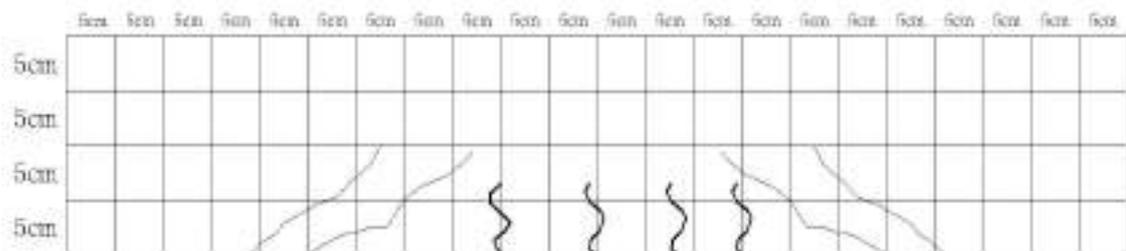
There is a significant improvement in crack patterns for beam repaired by UHPFRC and SRM which good bonding between the repair materials and the old concrete see Figure 5-20, while the crack patterns of beams repaired by OPC and UHPC are similar to cracking pattern of the control beam which shows less bonding between these materials and the old concrete.

Crack pattern of control beams

Crack pattern of UHPC beams

Crack pattern of UHPFRC beams

Crack pattern of OPC beams

Crack pattern of SRM beams

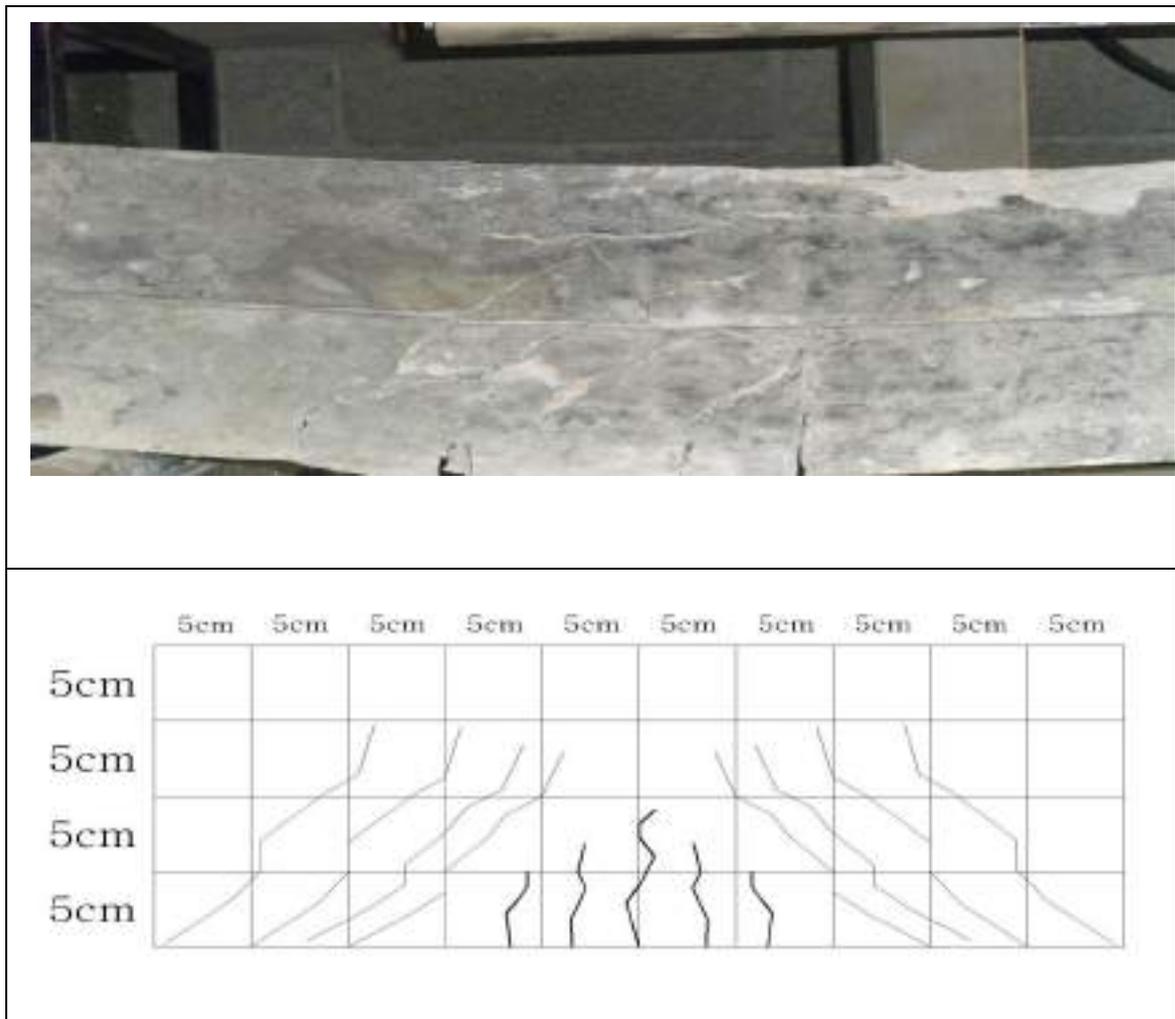
Control beam samples are tested under 4-point load and increasing the load slowly until failure to get the flexural capacity of section, crack pattern, and deflection. The average load obtained from the three tested samples after heating is 13.50 ton. This value is about 72% of the theoretical value of the section, which is 18.76 ton. The experimental results, together with the sample geometry, are reported in Table 6-1 and Figure 6-2. Crack patterns were taken and drawn to make a comparison with the repaired beams and shown in Figure 6-1.

Figure 6-1: Crack Pattern of Control Beams

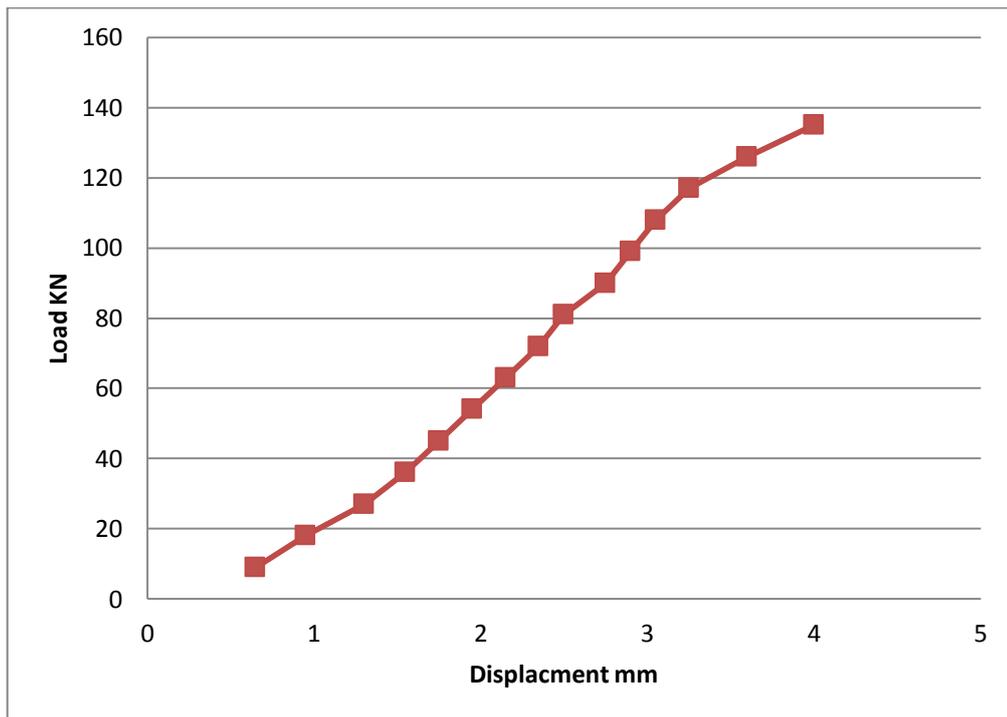
Load (KN)	Deflection (mm)
9	0.65
18	0.95
27	1.3
36	1.55
45	1.75
54	1.95
63	2.15
72	2.35
81	2.5
90	2.75
99	2.9
108	3.05
117	3.25
126	3.6
135	4

Figure 6-2: : Mid Span Displacement

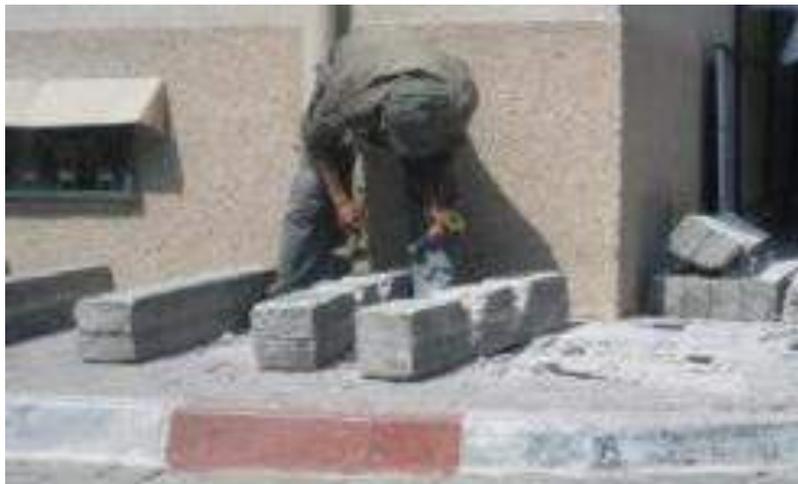
3rd Remove the samples form the furnace and cool it in normal conditions without spreading water on it, as shown in Figure 6-4:

Figure 6-4: Heated beam get cooled

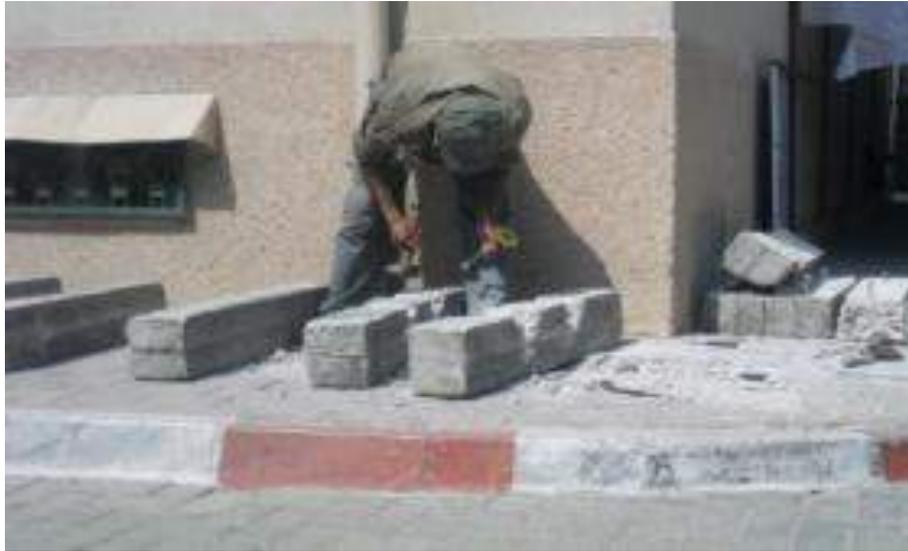
4th Chip the concrete cover of the samples and roughen the surface to ensure a good bond with the repair materials, as shown in Figure 6-5.

Figure 6-5: chip the concrete cover of the heated samples

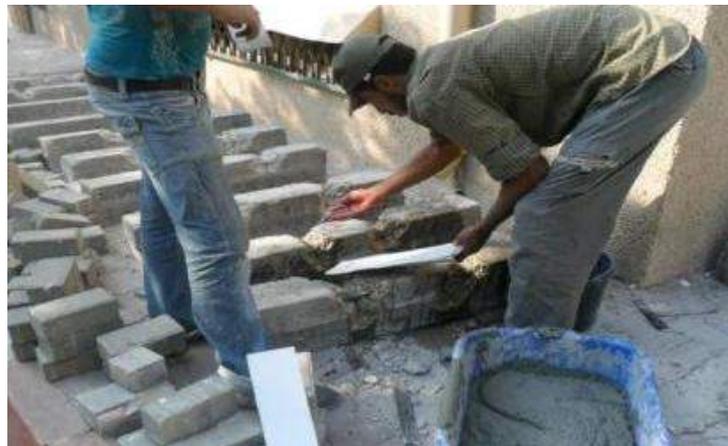
5th Wash the samples, as shown in Figure 6-6.

Figure 6-6: Cleaning the samples by Water

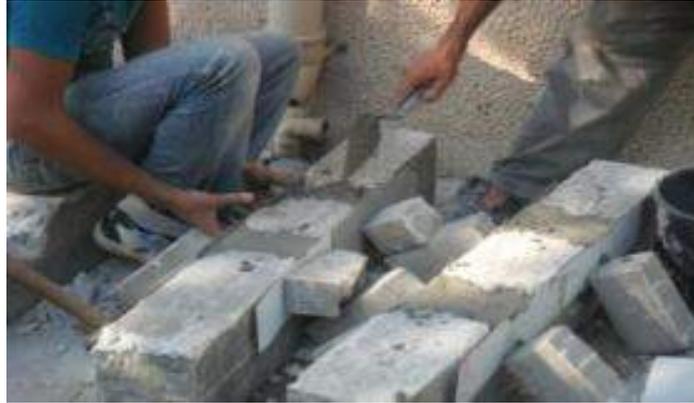
7th Prepare the required material quantity of UHPC for application, see Figure 6-7:

Figure 6-7: Applying UHPC matrix to the heated beams

8th Cure the samples after applying the UHPC matrix for 7 days.

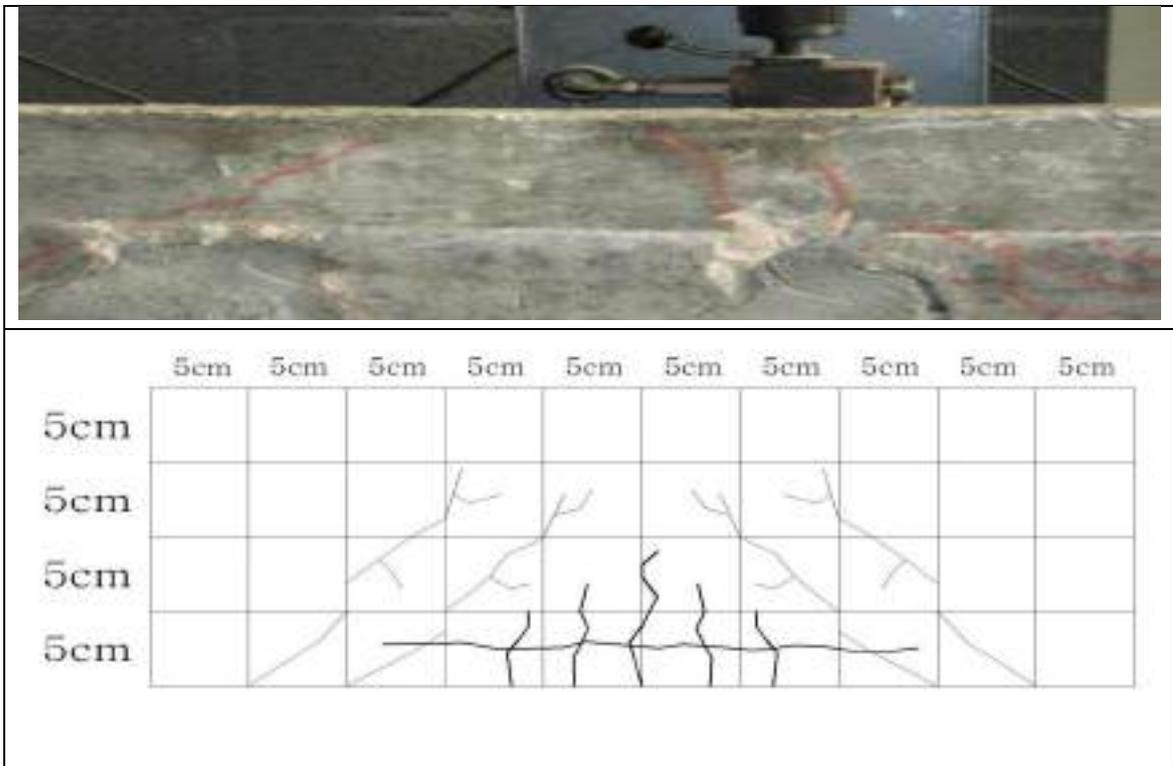
9th Test the samples by UHPC and record the results, flexural capacity, crack pattern, and deflection. (See Figure 6-8):

Figure 6-8: Heated beams repaired by UHPC tested , and its crack pattern

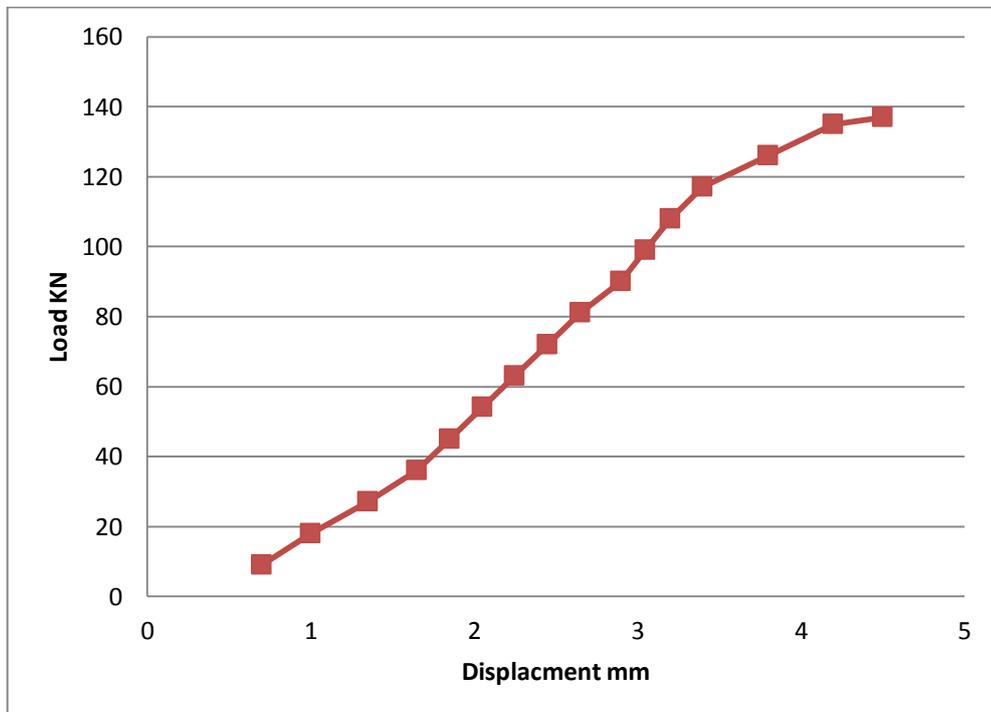
Load (KN)	Deflection (mm)
9	0.7
18	1
27	1.35
36	1.65
45	1.85
54	2.05
63	2.25
72	2.45
81	2.65
90	2.9
99	3.05
108	3.2
117	3.4
126	3.8
135	4.2
137	4.5

Figure 6-9: Displacement – load curve for heated beams repaired using UHPC

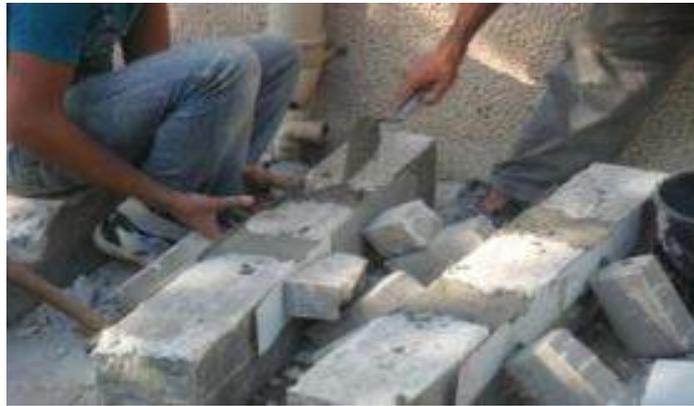
7th Prepare the required material quantity of UHPFRC for application, see Figure 6-10:

Figure 6-10: Applying UHPC matrix to the heated beams

8th Cure the samples after applying the UHPC matrix for 7 days.

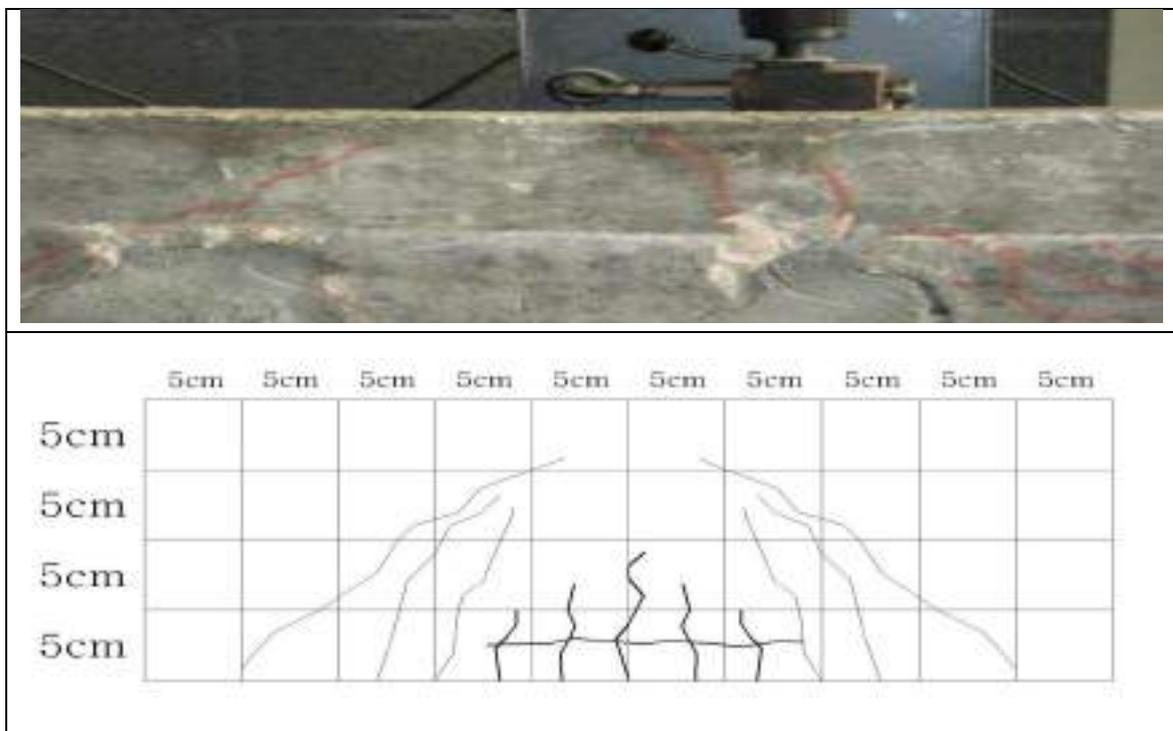
9th Test the samples by UHPFRC and record the results, flexural capacity, crack pattern, and deflection. (See Figure 6-11):

Figure 6-11: Heated beam repaired by UHPFRC tested , and its Crack Pattern

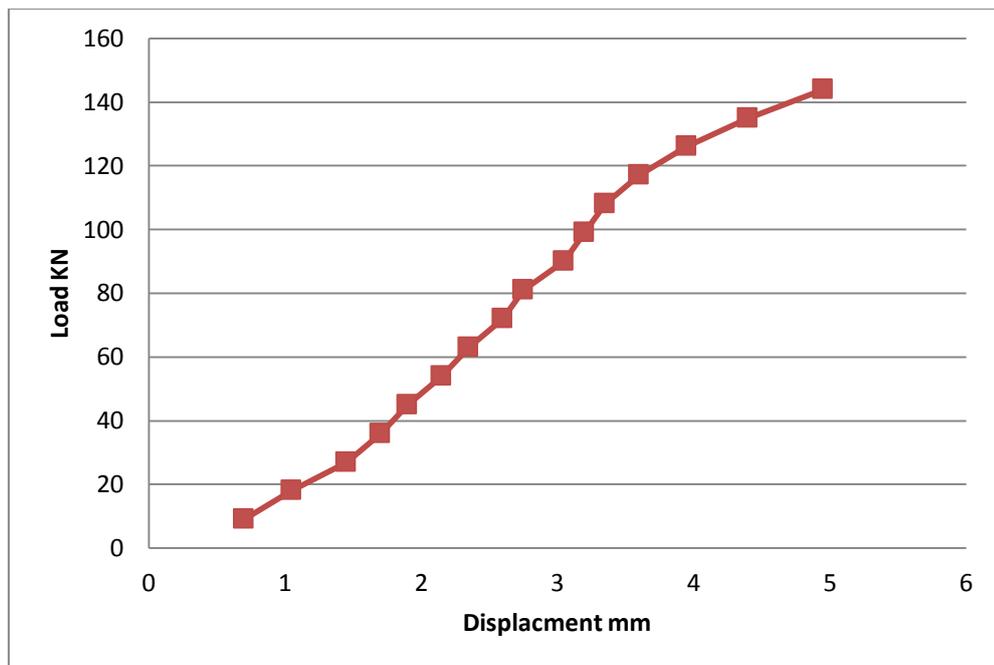
load (KN)	Deflection (mm)
9	0.7
18	1.05
27	1.45
36	1.7
45	1.9
54	2.15
63	2.35
72	2.6
81	2.75
90	3.05
99	3.2
108	3.35
117	3.6
126	3.95
135	4.4
144	4.95

Figure 6-12: Displacement – load curve for heated beam repaired by UHPFRC

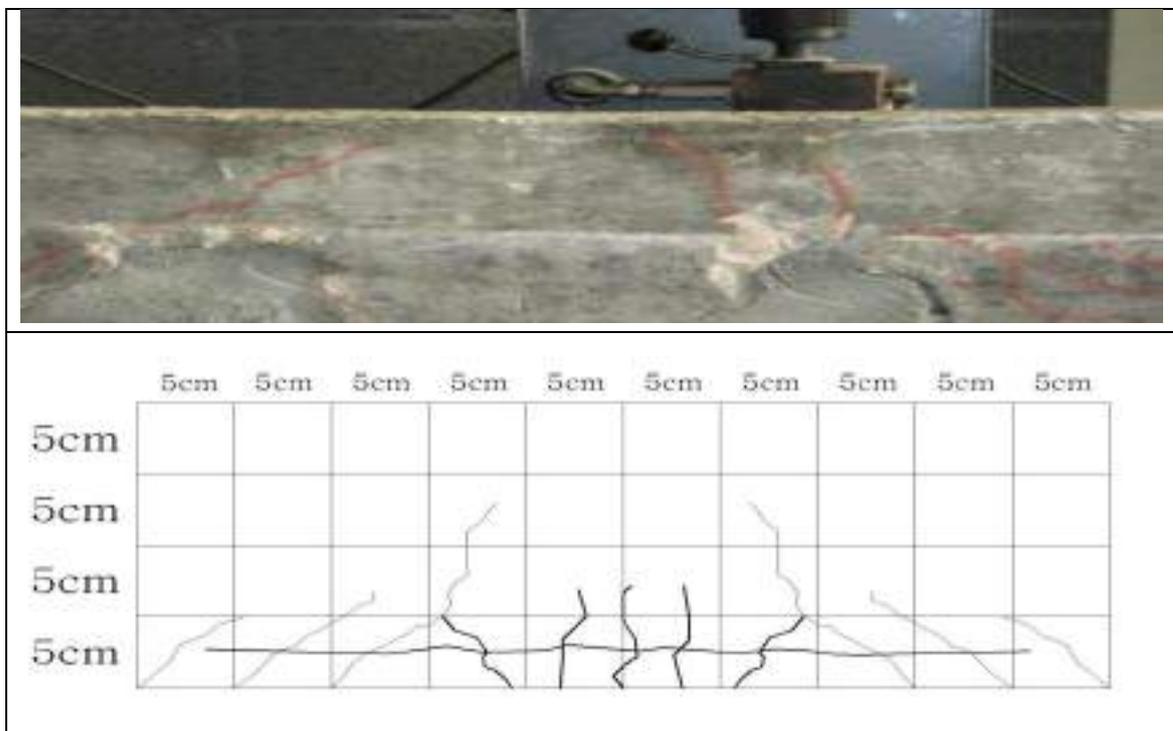
9th Test the samples by OPC and record the results, flexural capacity, crack pattern, and deflection. (See Figure 6-14):

Figure 6-14: Heated beam repaired by OPC tested , and its Crack Pattern

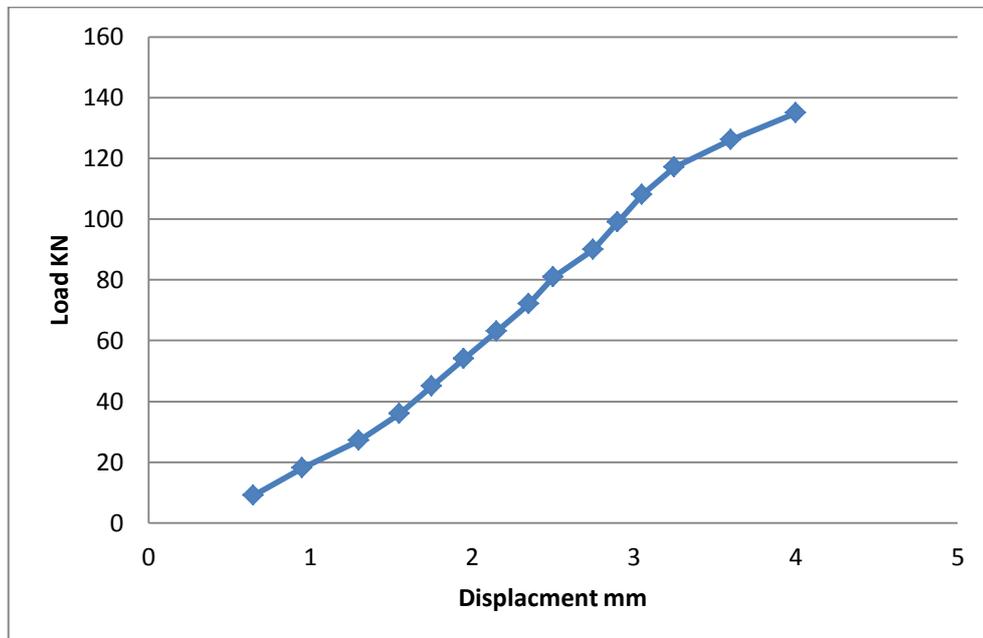
Figure 6-15: Displacement – load curve for cracked beam repaired by OPC

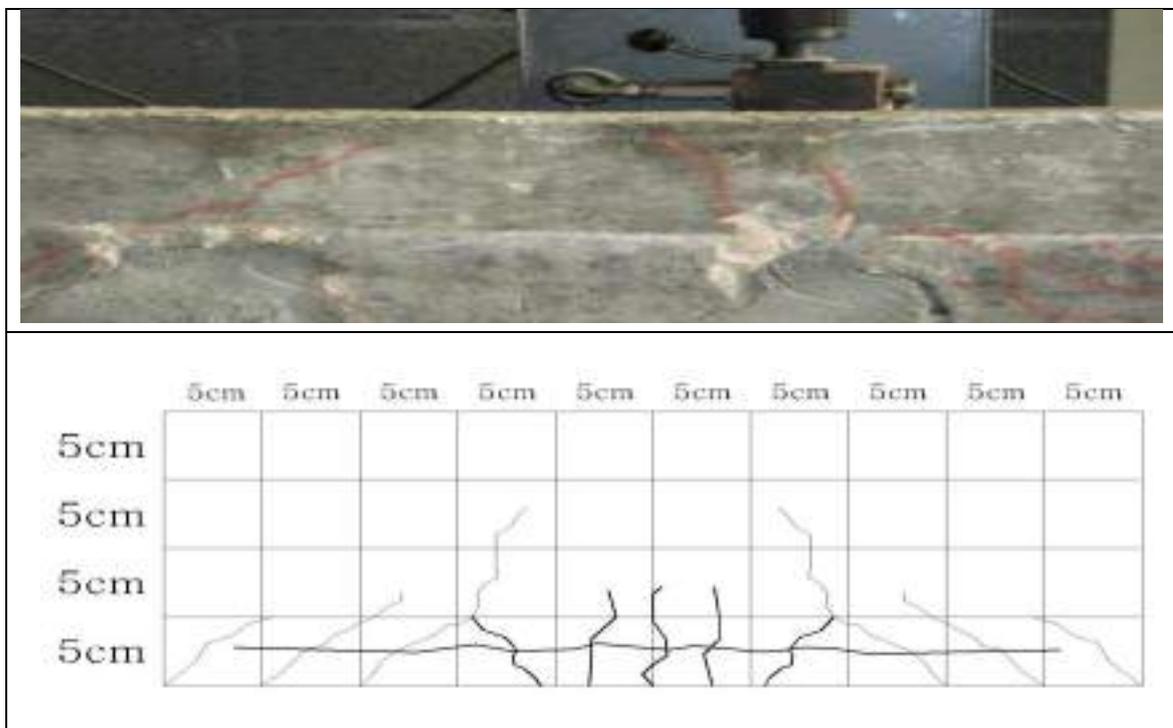
Figure 6-17: Heated beam repaired by SRM tested , and its Crack Pattern

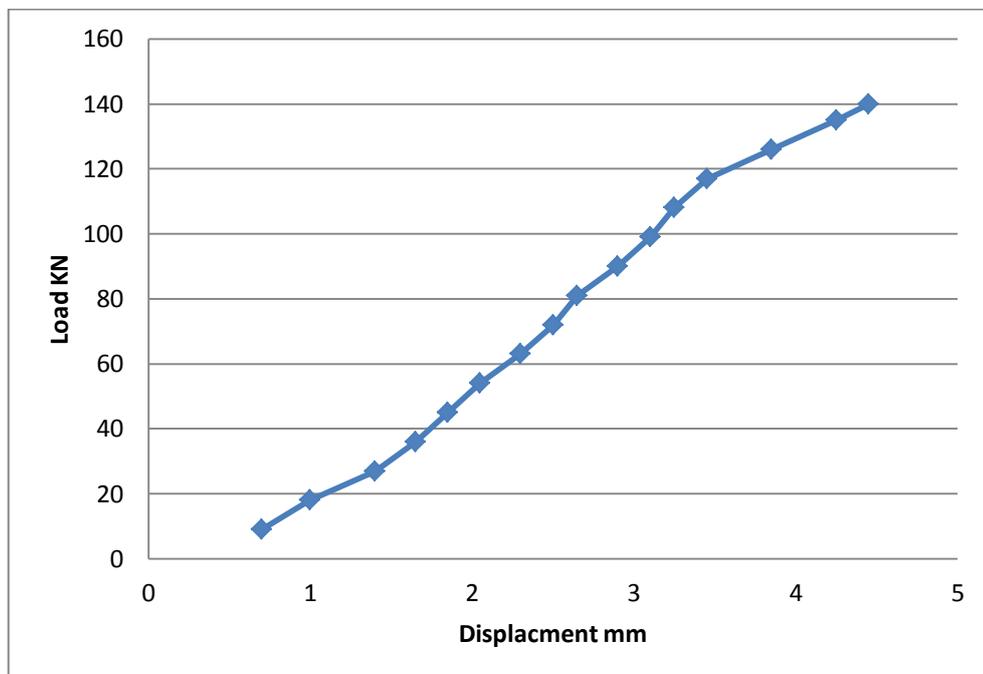
Figure 6-18: Displacement – load curve for cracked beam repaired by SRM

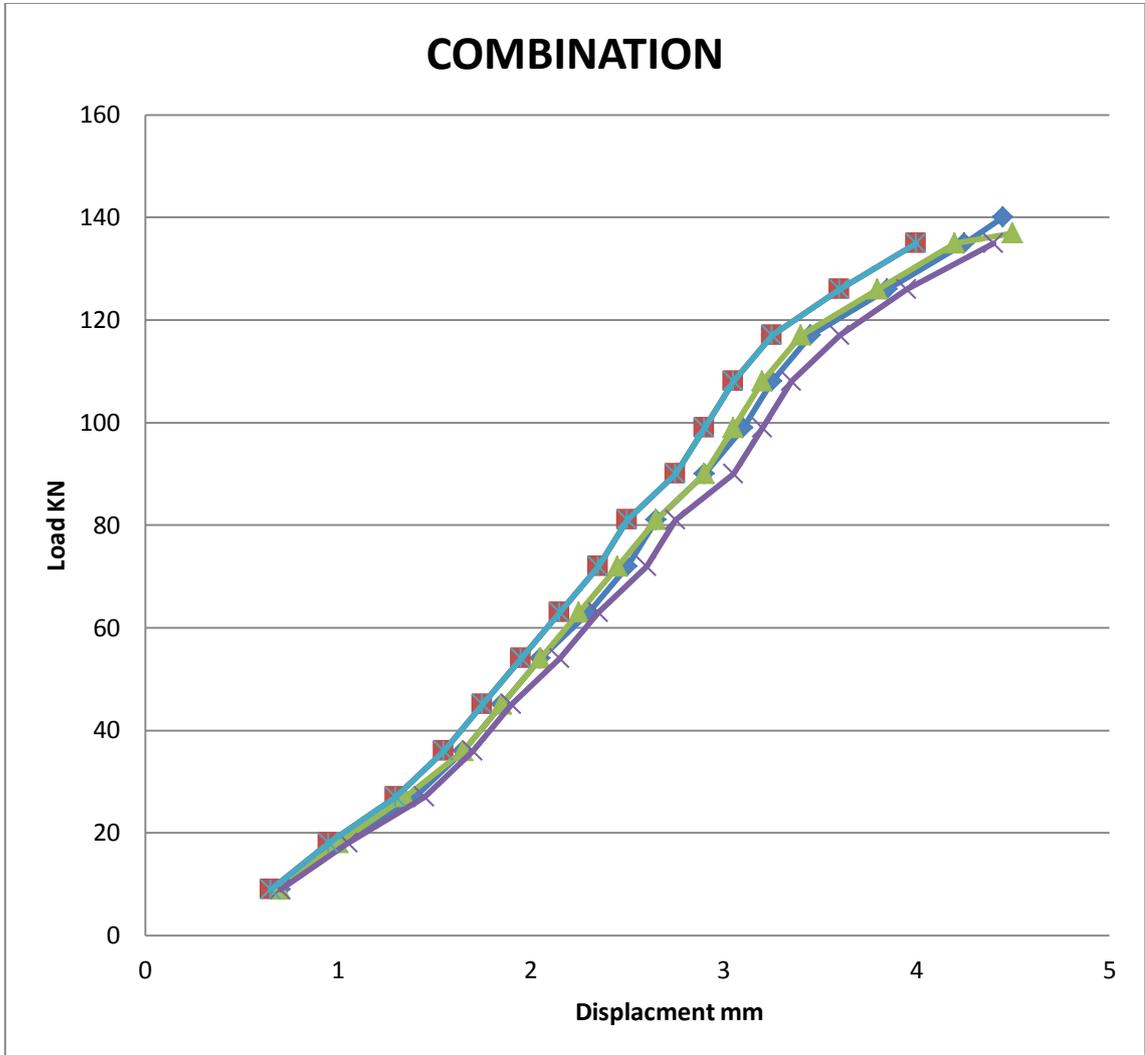
Figure 6-19: Load - Deflection Relationship
