The Islamic University of Gaza
Deanery of High Studies
Faculty of Engineering
Department of Civil Engineering
Design and Rehabilitation of Structures

Structural Performance of Repaired Corroded Reinforced Concrete Beams

A Thesis Submitted in Partial Fulfillment of the Requirements for the Degree of
Master of Science in Engineering- Rehabilitation and Design of Structures

July, 2009

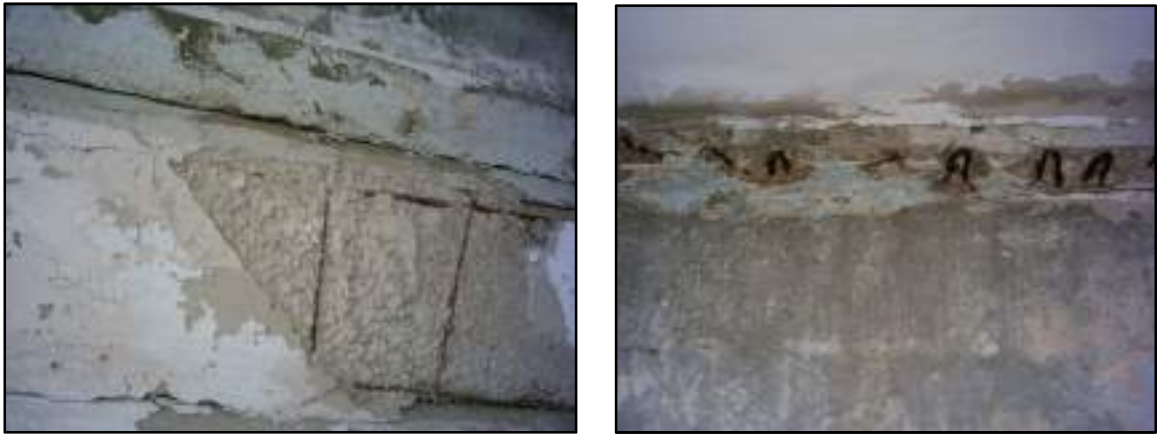
Figure 1.1 show photos of some corroded reinforced concrete beams. These pictures were taken from a repairing of 104 shelters project at Rafah area in Gaza Strip, executed by the United Nations Relief and Works Agency (UNRWA) 12-2006.

Figure 1.1: Some Pictures of Corroded Reinforced Concrete Beams

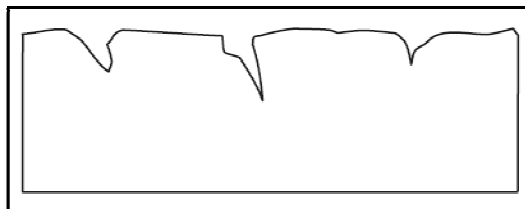
Figure 2.6: Pitting Corrosion (El-Reedy, 2008)

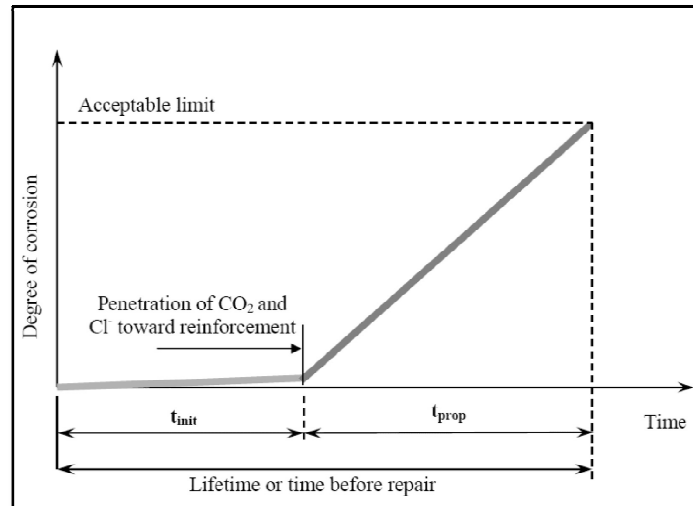
attempts to predict the service life of RC structures. As shown in Figure 2.7, the concept of this model is to divide the service time of the structure into T_0 (t_{init}), as the time to corrosion initiation, and T_i (t_{prop}), as the time of corrosion propagation until failure occurs (**Alizadeh and others, 2006**).

Figure 2.7: Tutti's Model for Corrosion Process of Steel in Concrete (**Alizadeh and others, 2006**)

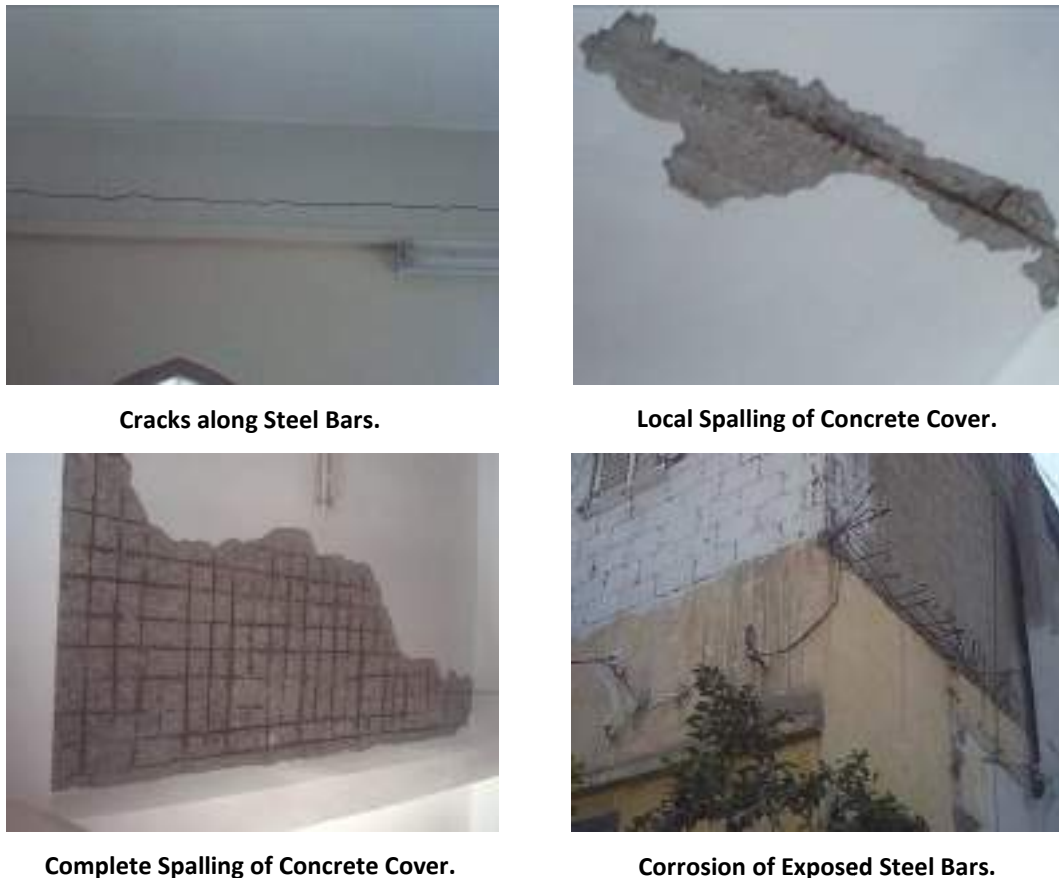
Figure 2.11 shows the reinforcing steel corrosion problem of many buildings in Gaza Strip.

**Figure 2.11: Steel Reinforcement Corrosion in Different Defects Buildings in Gaza Strip
(Abu Hamam, 2008)**

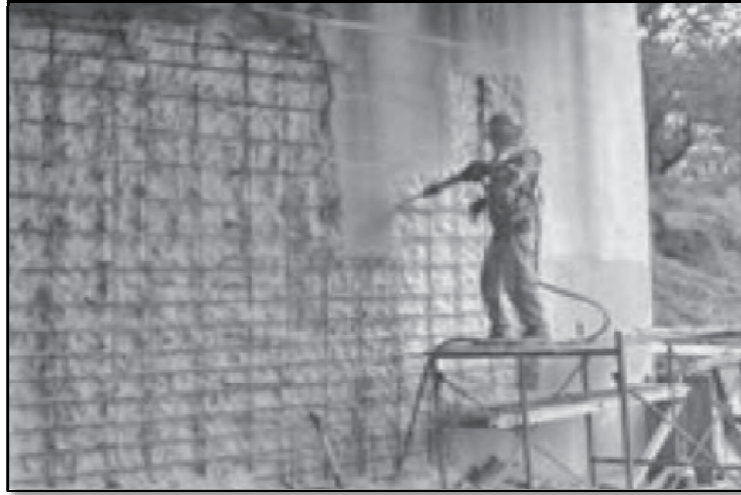
The use of pneumatic hammers is more economical when a small, rather than large, area is to be removed (see Figure 3.4). A water gun is preferable for large areas as described in the following section (El-Reedy, 2008).

Figure 3.4: Using a Pneumatic Hammer to Remove Wall Concrete Cover (El-Reedy, 2008)

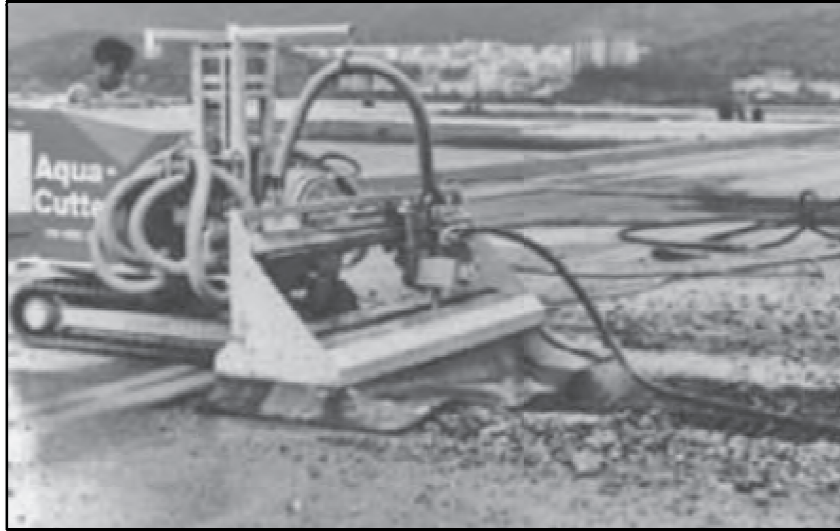
Figure 3.7: Grinding Machine (El-Reedy, 2008)

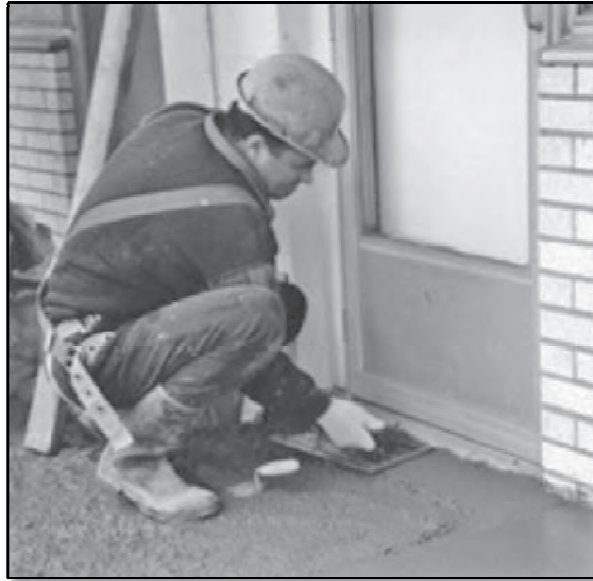
Figure 3.10: Manual Method for Repair (El-Reedy, 2008)

The manual method is used in most cases, especially when small spaces are to be repaired (Figure 3.10). A wooden form can be made and then concrete can be poured into the damaged part, as in Figure 3.11, in the case of concrete columns or vertical walls. One must take into account an appropriate distance to cast the concrete in the wooden form easily. This method is commonly used for its efficiency and has little cost. It does not require expensive equipment, but extensive experience in fabrication,

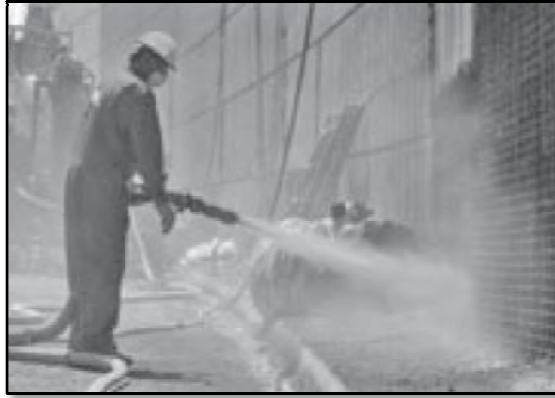
Figure 3.13: Using Shotcrete (El-Reedy, 2008)

Shotcrete is used when large surfaces need to be repaired, but the mix and components of concrete suitable for the use in shotcrete need special additives and specifications. As shown in Figure 3.13, health and safety precautions must be carefully followed for the worker using shotcrete, as it contains polymers and special additives. In the concrete mix design, the nominal maximum coarse aggregate size must be defined to be suitable to the shotcrete equipment's nozzle and pump to avoid any problem during concrete casting. Complete member casting is used when total reconstruction is required for the concrete member whose steel reinforcement bars have been depleted due to corrosion. Therefore, it is necessary to pour concrete for the complete member with full depth, as shown in Figure 3.14 (U.S. Army Corps of Engineers, 1995).

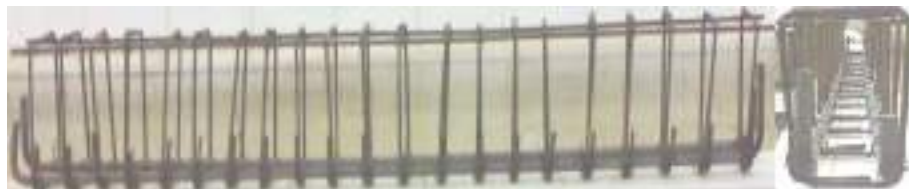
Figure 4.2: Steel Bars Cage

Fourteen beams with dimensions 1200x150x100 mm, shown in Figure 4.1 and Figure 4.2, were used in the test program.

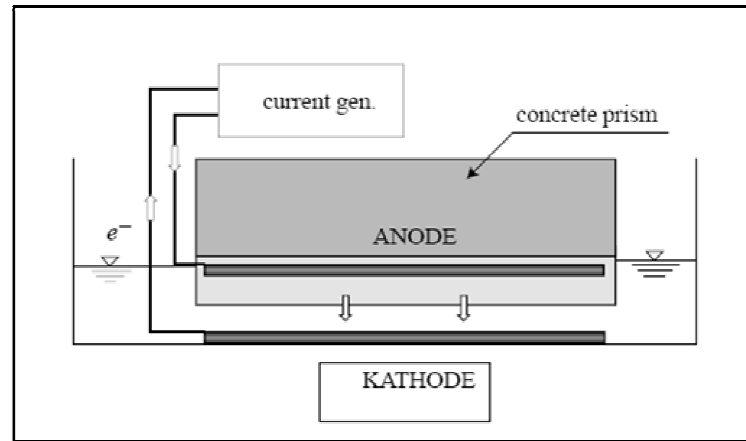
The main difficulty during this work was how to develop an electrochemical system in order to accelerate the corrosion process. In fact many previous studies discussed similar systems. **Fazio, 1996** and **Kovacs, 2000** are some researches who dealt with such systems. For example Figure 4.4 shows Kovacs technique used for accelerating the reinforcement corrosion process.

Figure 4.4: Drawing Of Steel Reinforcement Corrosion Accelerating Technique (Kovacs, 2000)

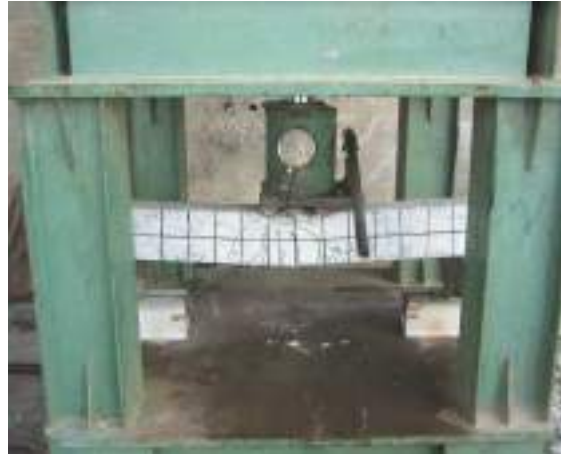
The second difficulty that there was no machine in Gaza strip that can test the flexural capacity of reinforced beams specimens, a manual hydraulic jack with a compression strength capacity of 50 tons connected with a steel frame as seen in Figure 4.5 was used. A pressure gauge with an accuracy of ± 1 KN was connected to the hydraulic jack and then the machine was calibrated by a standered loading cell.

Figure 4.5: flexural test machine (I.U.G. Laborite's Machine)

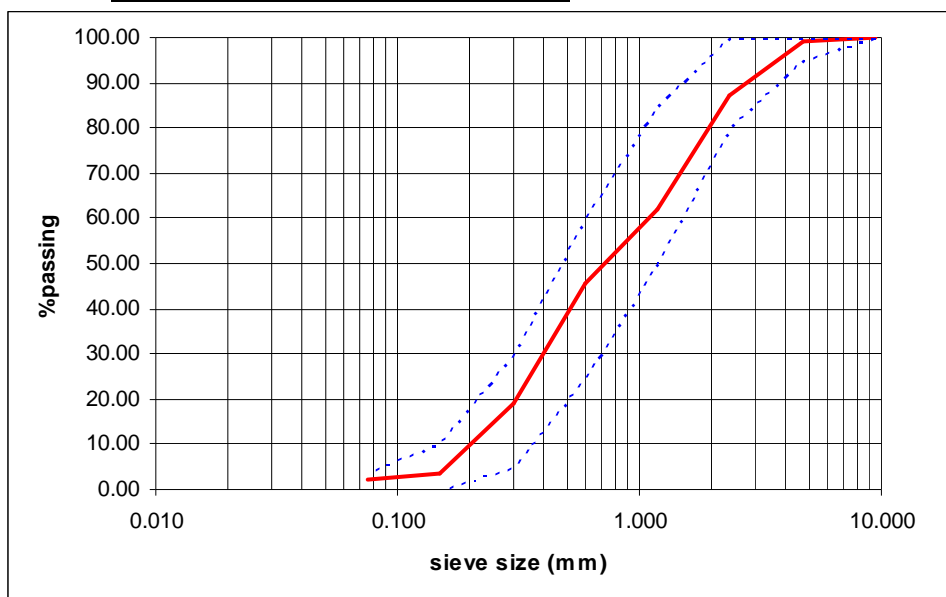
Figure 4.7: Fine Aggregate Sieve Analysis According To ASTM C33-03 Limitation

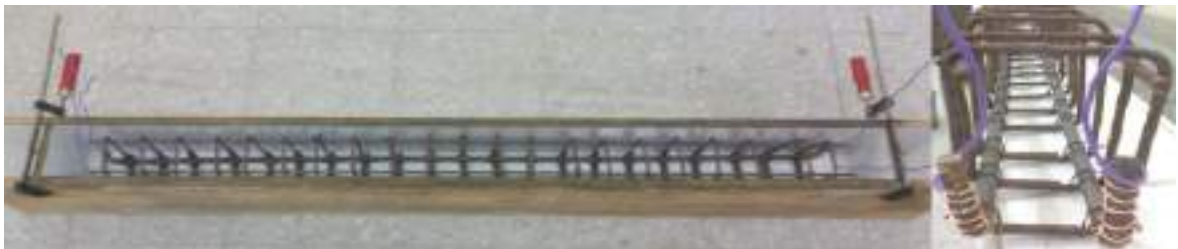
Form of wood for constructing beams was prepared as seen in Figure 4.8.

Figure 4.8: Wood Form and Reinforcement Details

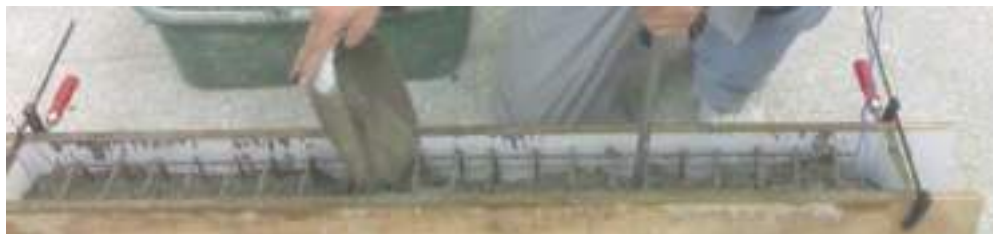
The mixing of concrete was mixed in a conventional blade-type mixer according to ASTM C192 procedure. Figure 4.9 shows the casting process. Prior to the casting of the beams, an electric wire was attached to the reinforcement bars using a garden hose clamp. This wire was used to impress the necessary voltage for the corrosion process to proceed.

Figure 4.9: Casting Process

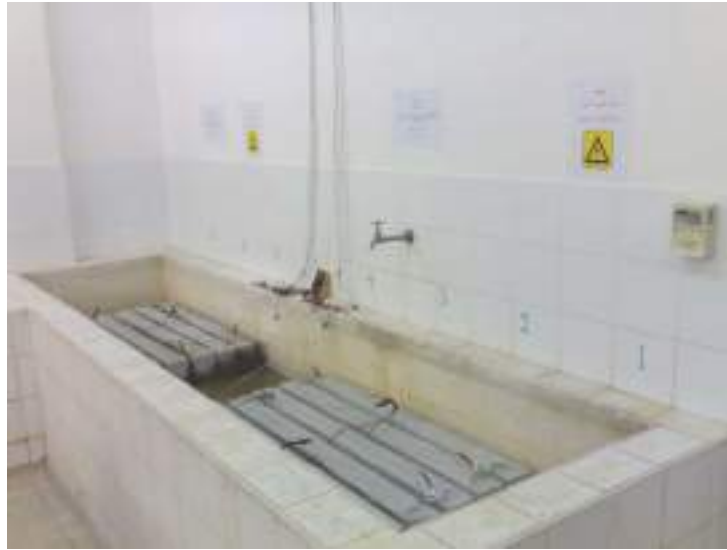
Figure 4.10: Curing Basin Used In The Study

All beam specimens on its wood form base were moved to a curing basin after 24 hours from casting. The curing conditions were according to the ASTM C192 standard. Figure 4.10 shows the appearance of curing basin which used in this study.

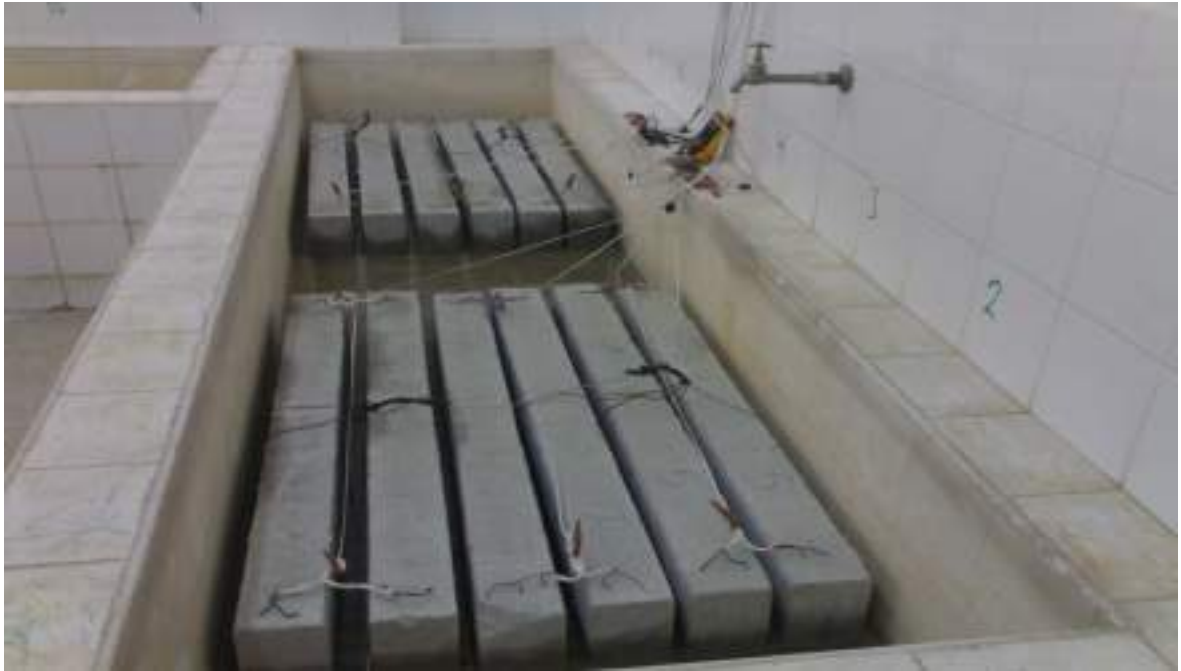
Figure 4.11 shows the electrical connection of beams. While Figure 4.12 shows the rust developing on the beam surface at the end of electrochemical corrosion process.

Figure 4.11: Electrical Connection of Beams

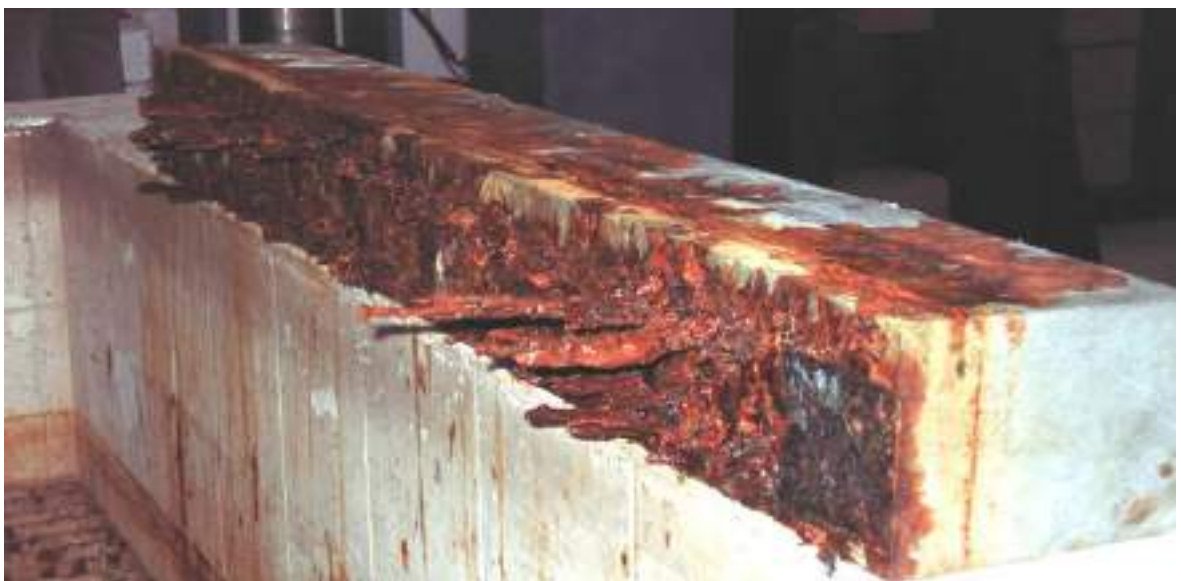
Figure 4.12: Rust on Beams at the End of Corrosion Process

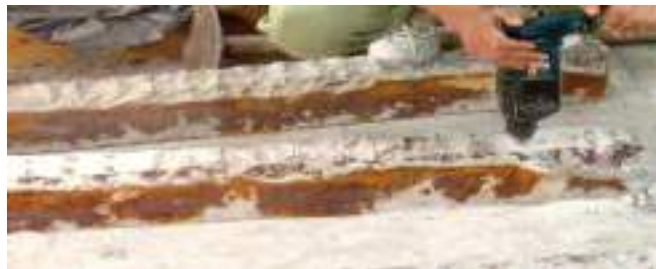
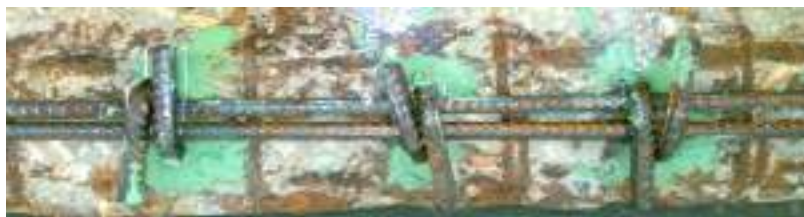
5. The beams were left for 24 hours, and then two 8 mm steel reinforcing bars were installed in the flexural zone and connected with the shear connectors as discussed in the test program. Figure 4.13 shows the installing of shear connectors during the experimental works.

Figure 4.13: Installing Of Shear Connectors

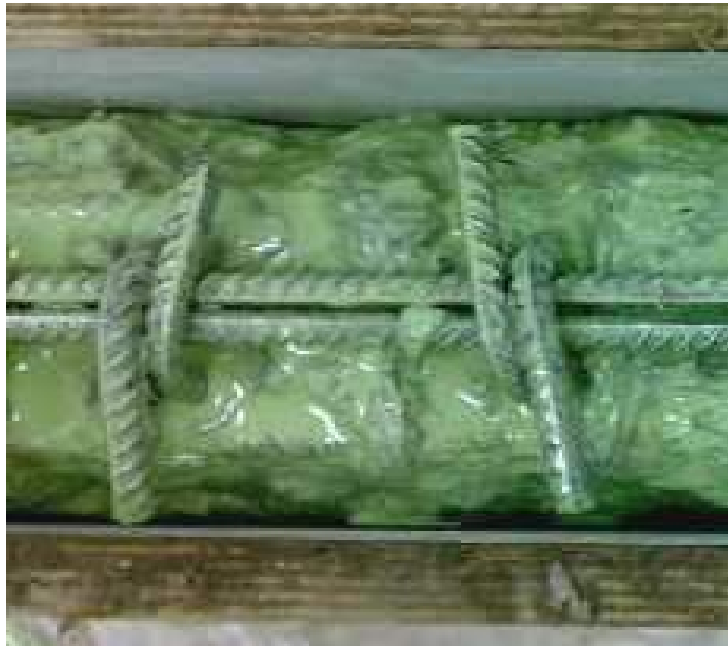
Figures 4.14 and 4.15 show repaired materials while being installed.

Figure 4.14: Repair Material Type 2 Brushed On Beams

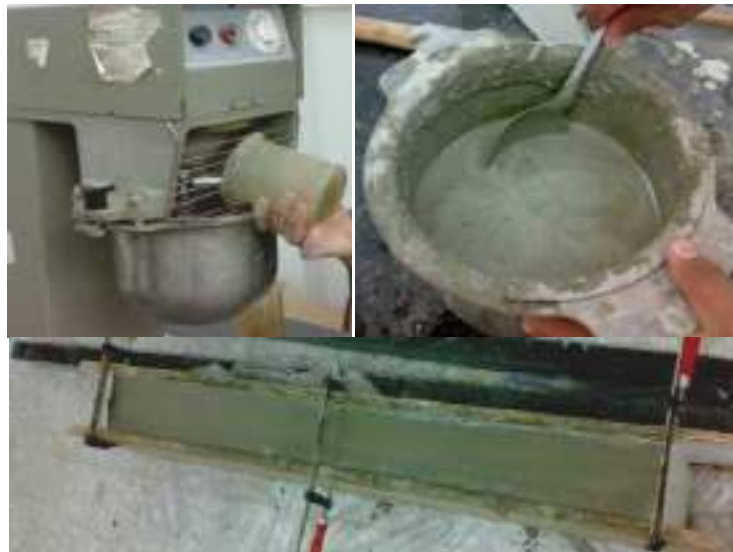
Figure 4.15: Repairing Material Type 3 While Mixing and Casting

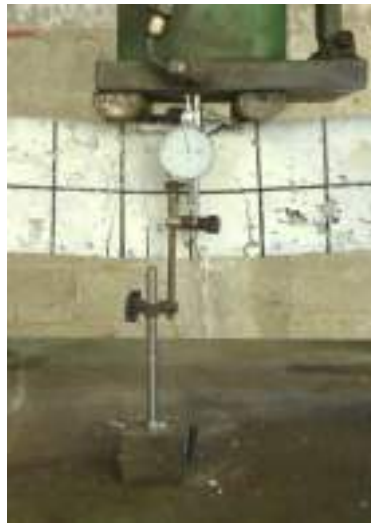
Beams specimens were tested as simply supported beams with two concentrated loads using the flexural testing machine discussed previously. Two 30 mm in diameter steel rods were used as edge simply supports while two steel bars with a semi-half circular section with radius of 40 mm were used to apply the middle concerted loads. A mechanical dial gauge was located at the mid-span to measure the deflection caused by changing of the applied load as seen in Figure 4.16. The load was increased with 0.785 KN increment and the corresponding deflection readings were recorded for each 4 KN load increment.

Figure 4.16: Deflection Dial Gage Fixation

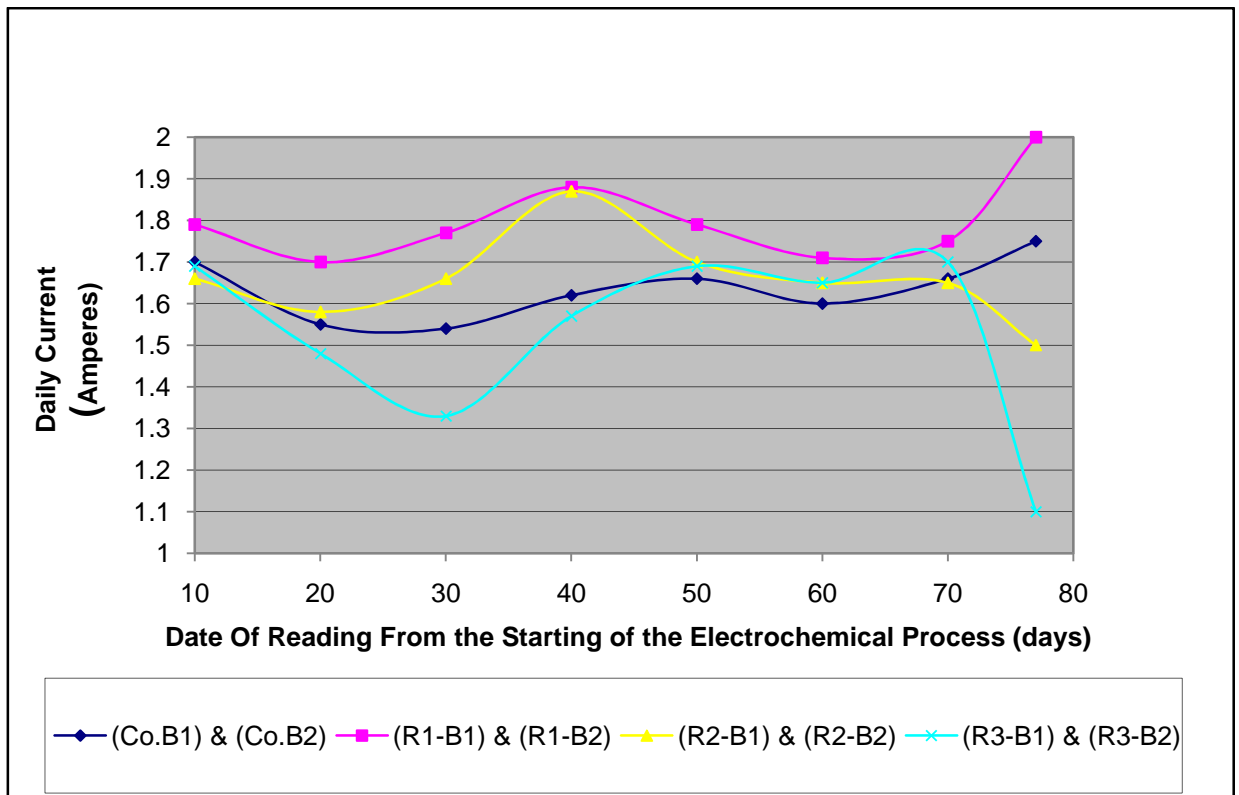
Figure 5.1: Beams Current Reading during the Electrochemical Process

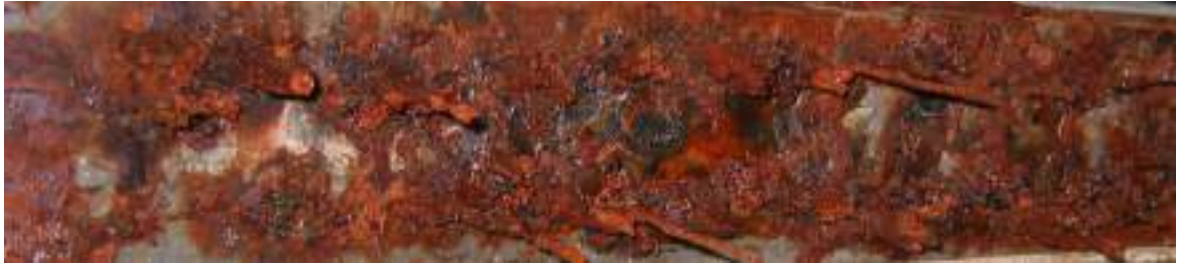
Figure 5.2: Rust on Beams during the Corrosion Process

After the end of electrochemical corrosion process, beams were left in air for fourteen days. This period was inessential to allow complete reaction between the iron ions with air to form the rust. Figures 5.2 and 5.3 show the rust accumulated on the beam bottom during and at the end of corrosion process.

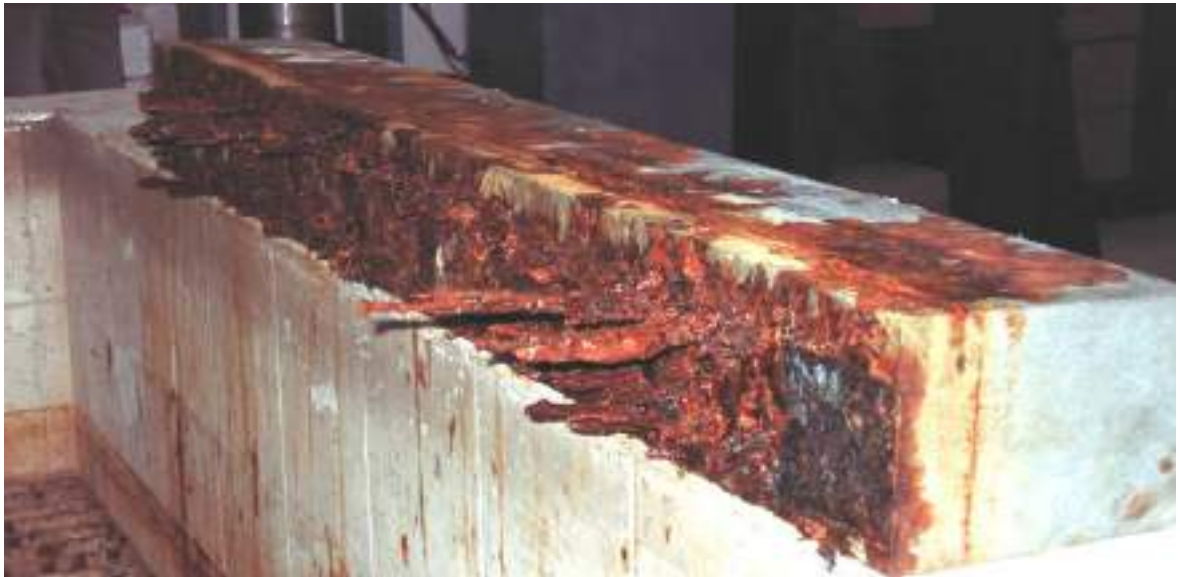
Figure 5.3: Rust on Beams At The End Of Corrosion Process

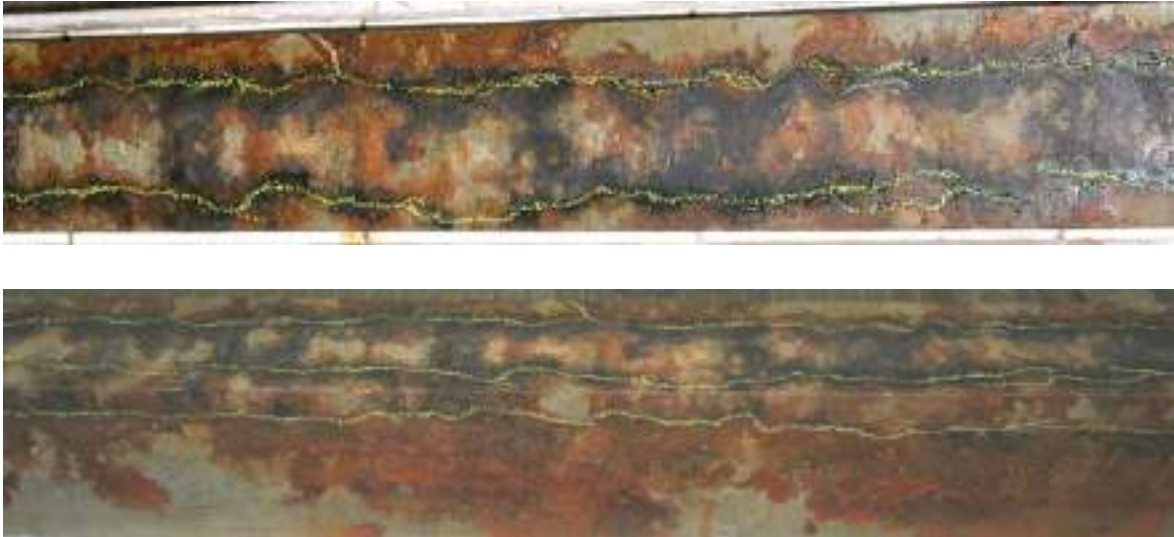
Figure 5.4: Cracks at the Bottoms Sides of Beams

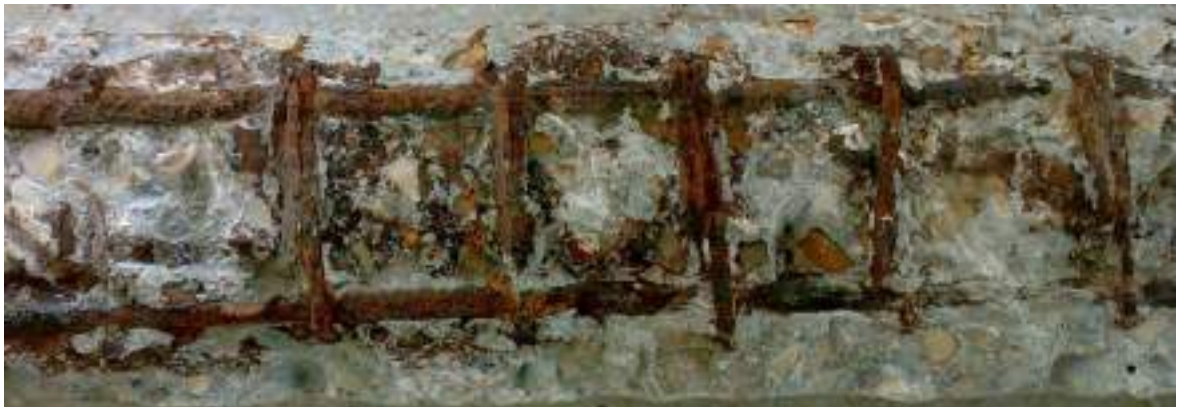
Figure 5.5: Steel Status after Corrosion

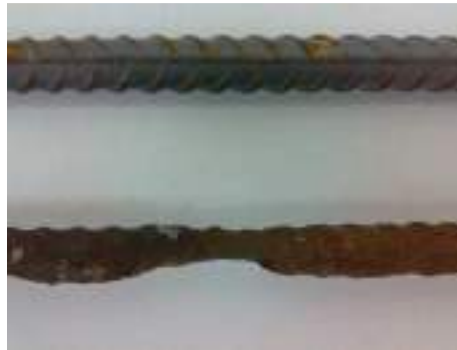
Figure 5.6: Corroded Steel Bar in Comparison with Non Corroded Steel Bar

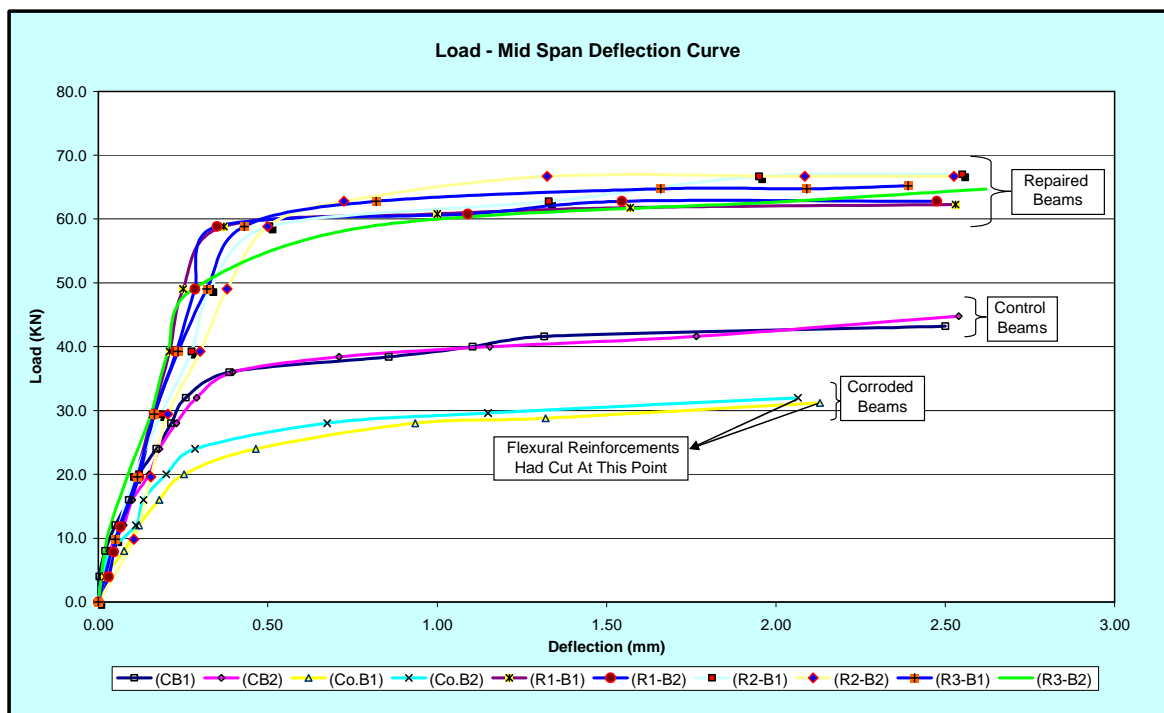
Figure 5.7: Load – Mid Span Deflection of Beams

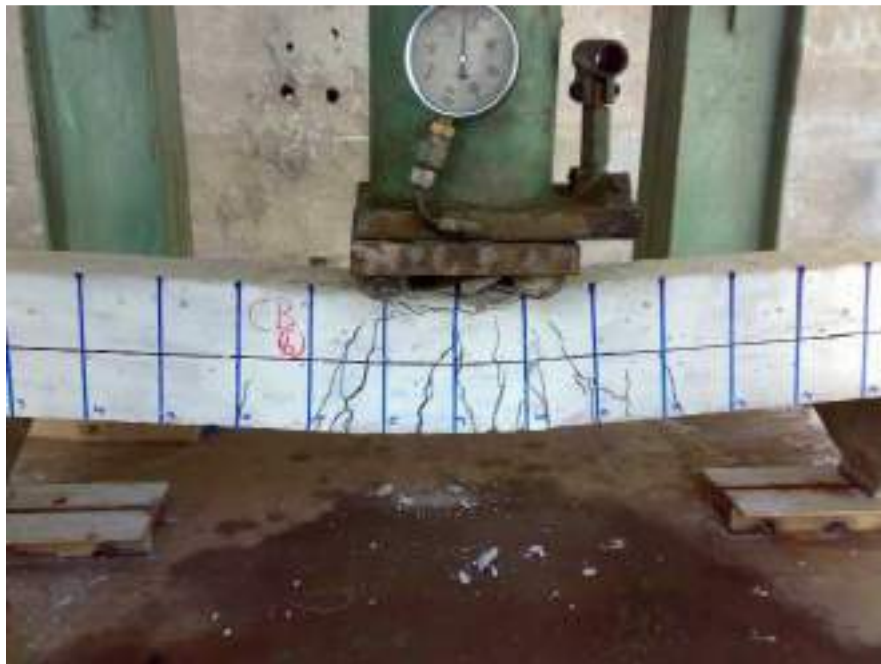
Figure 5.18: Crack Pattern Photo for Beam (CB2) At Failure

Figures 5.18 through 5.22 shows photos for the crack developments of some selected beams at failure:

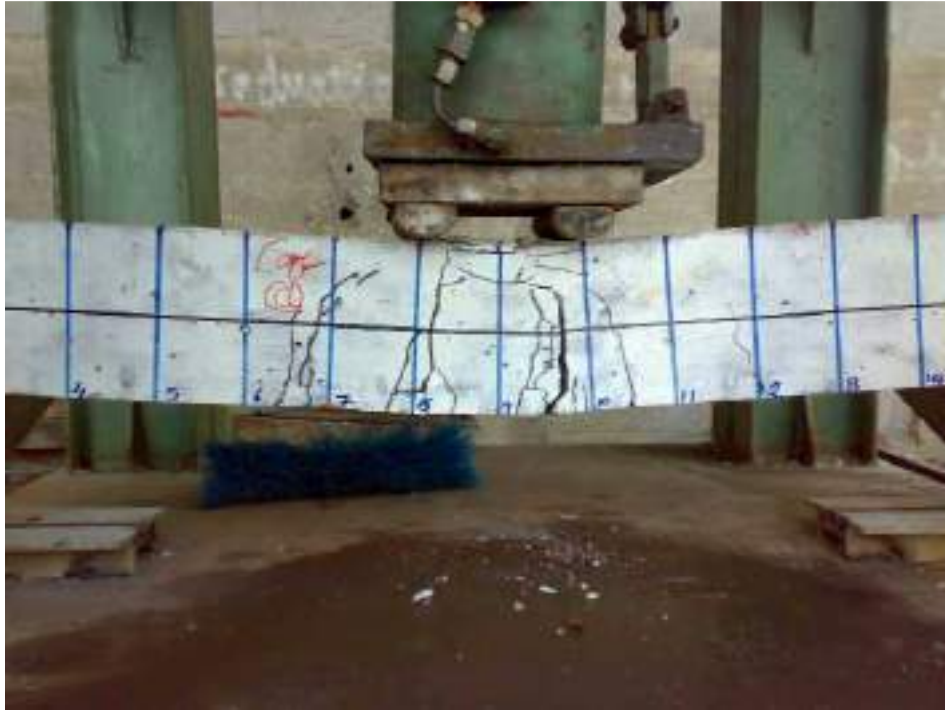
Figure 5.19: Crack Pattern Photo for Beam (Co.B1) At Failure

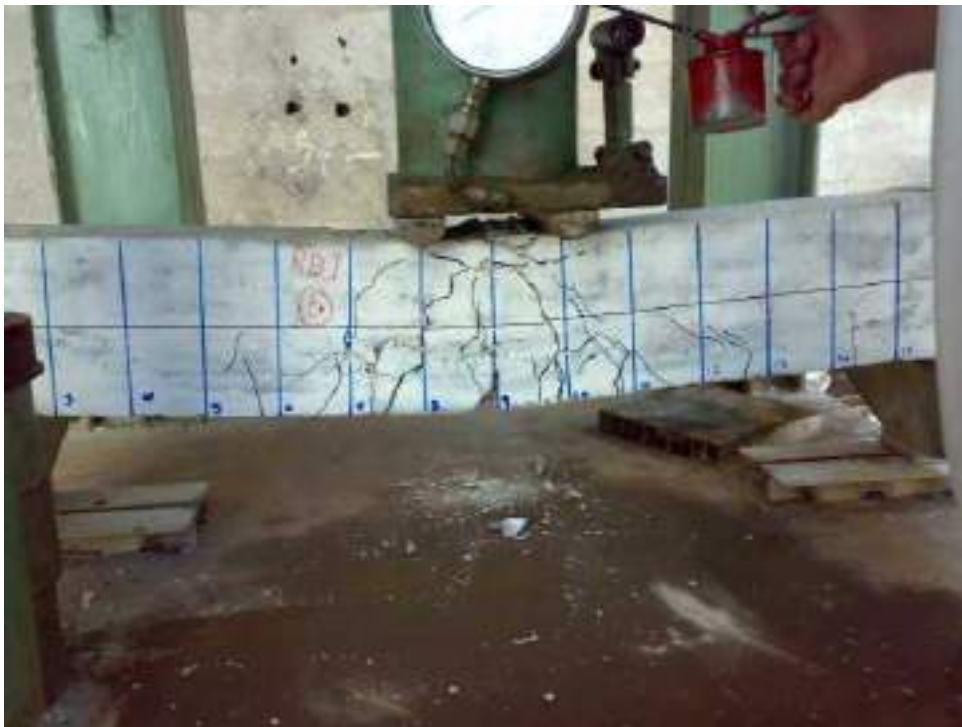
Figure 5.20: Crack Pattern Photo for Beam (R1-B1) At Failure

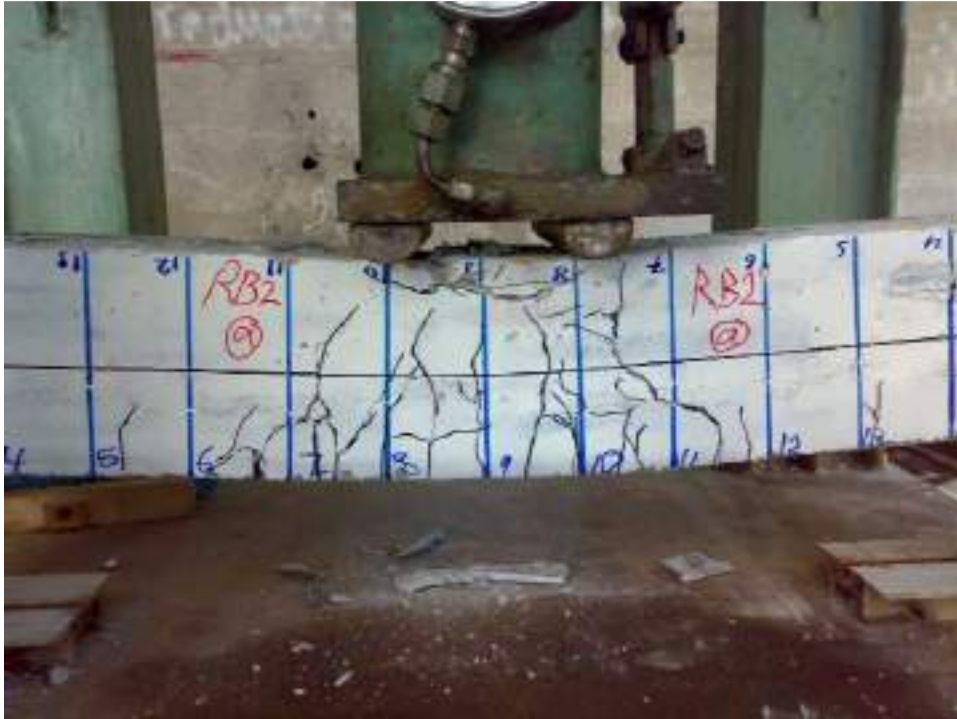
Figure 5.21: Crack Pattern Photo for Beam (R2-B1) At Failure

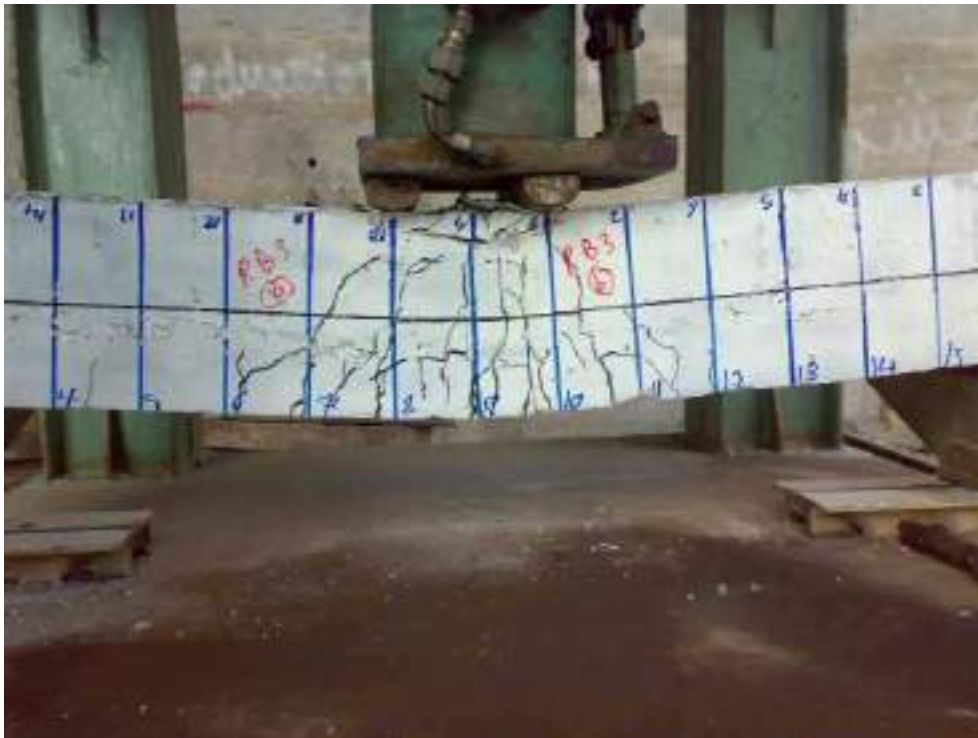
Figure 5.22: Crack Pattern Photo for Beam (R3-B2) At Failure

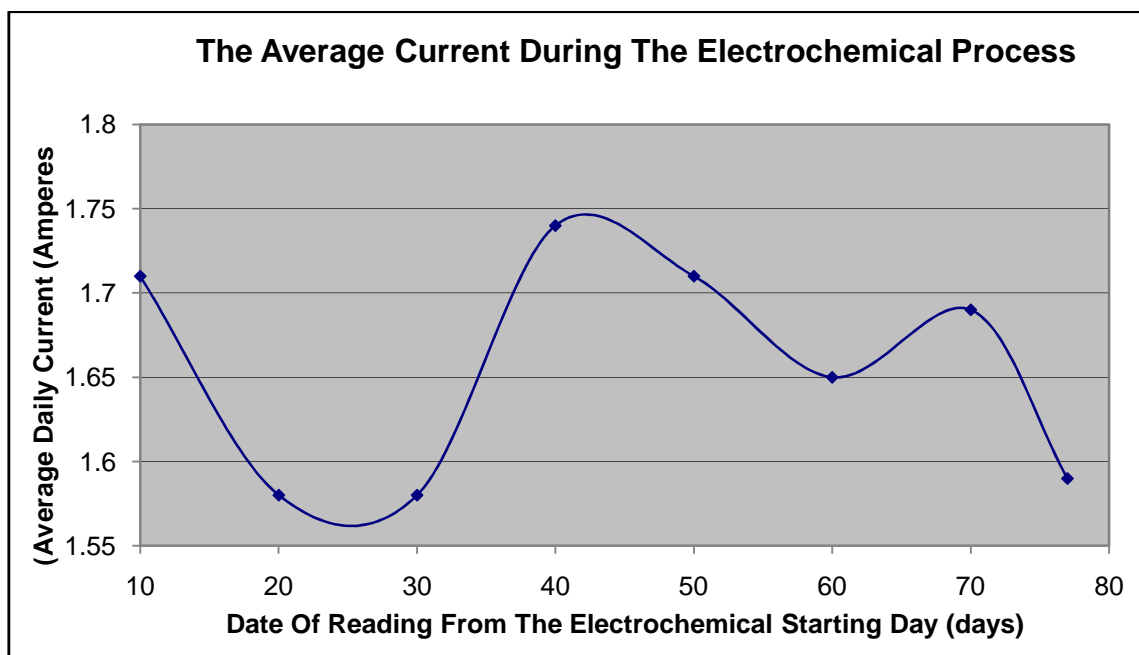
Figure 6.1: The Average Current during the Electrochemical Process
